Condition Assessment of Historic Properties and Associated Canal System

Lawrence Hydroelectric Project (FERC
No. 2800)

May 6, 2025

Essex Company, LLC
Manchester, New Hampshire

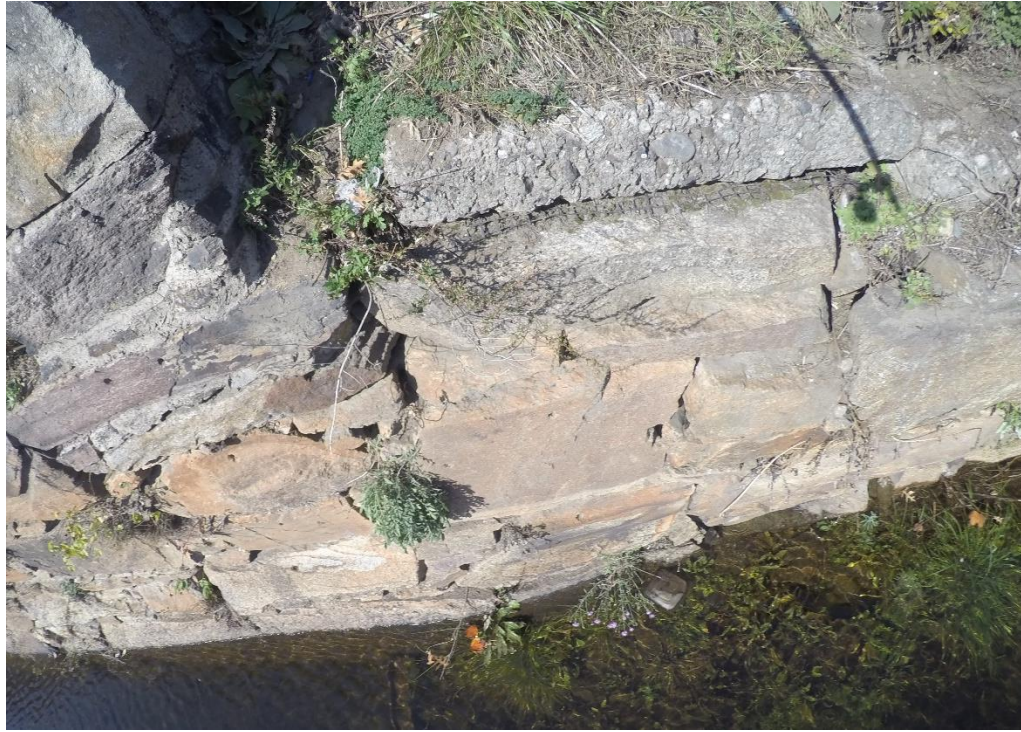
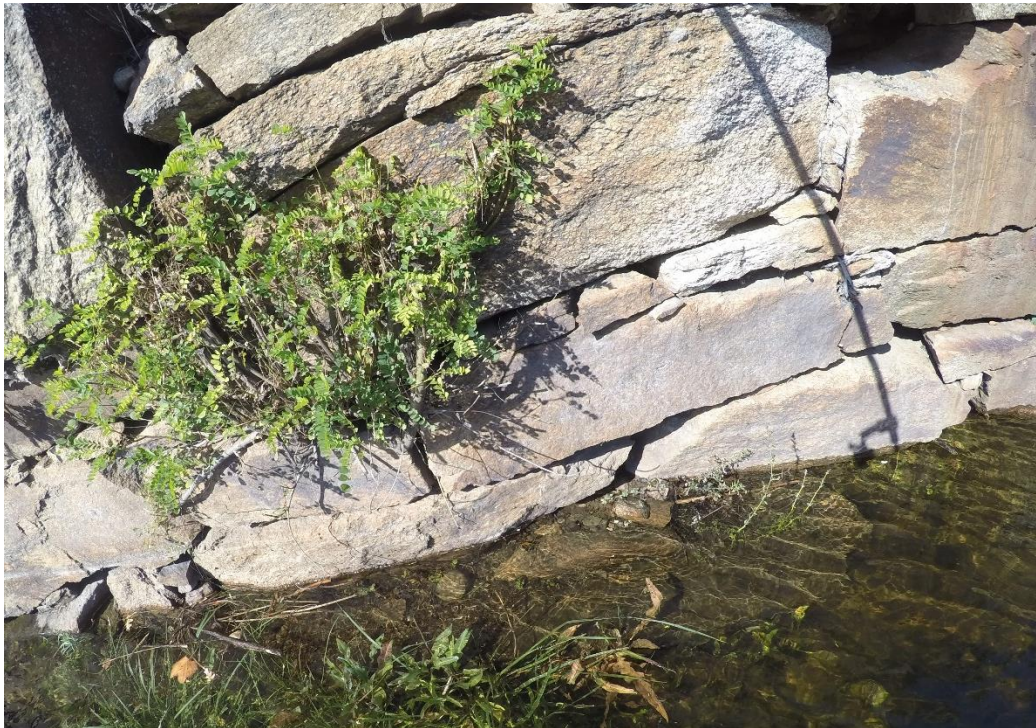
Wall Section	Station	Risk Level
NN5	3+30 to 4+00	2
Observations		
This wall section is comprised of dry-laid stone. This wall section is noted to have large areas of missing stones in various locations. Additionally, the crest of the wall is uneven and does not appear to be plumb with the rest of the wall. This is caused by areas of overhanging stone along the crest that do not form a flush face with the rest of the wall section. Also, the wall section has woody vegetative growth between stones.		
Recommendations		
All voids should be replaced with similar stones. Mortar should be placed between the joints, where possible, to bind the stones together and to prevent seepage to/from the canal. Existing stones that are not flush with the wall surface should be repointed. All vegetation should be removed where possible. If removing the root structures would negatively impact the structural stability of the wall, then the vegetation should be treated instead to prevent future growth.

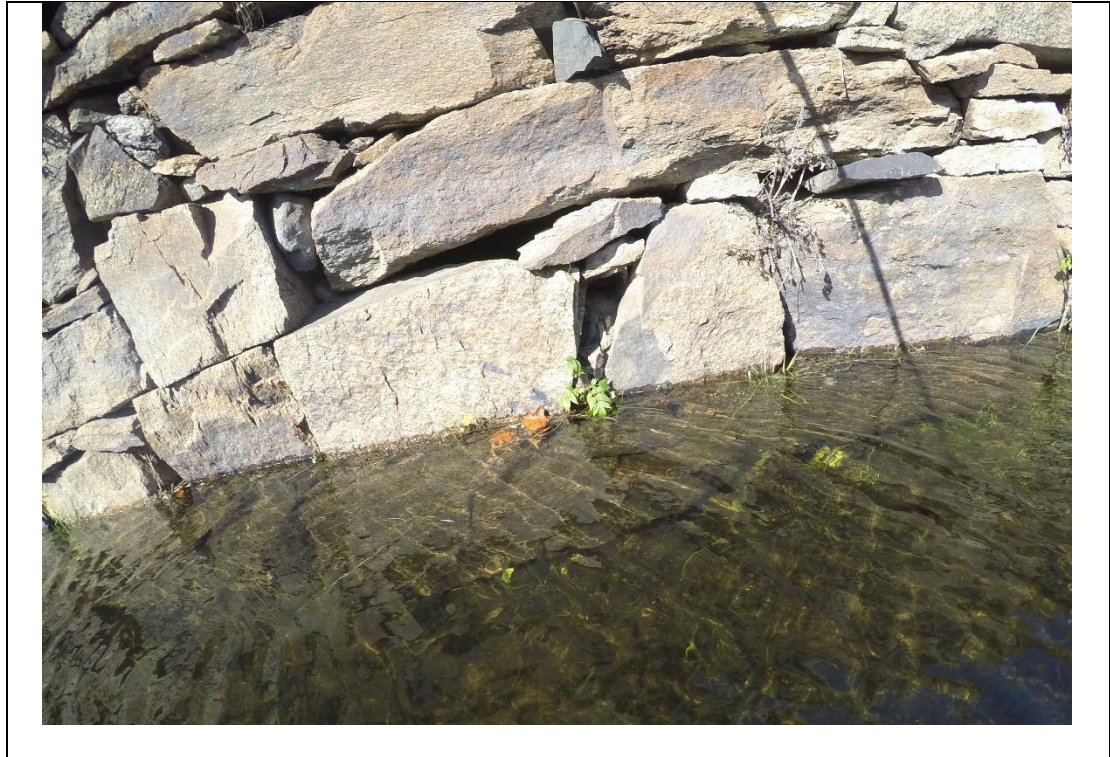
Wall Section	Station	Risk Level
NN6	4+00 to 4+70	2
Observations		
This wall section is comprised of dry-laid stone. This wall section is noted to have large areas of missing stones in various locations. Additionally, the crest of the wall is uneven and does not appear to be plumb with the rest of the wall. This is caused by areas of overhanging stone along the crest that do not form a flush face with the rest of the wall section. Also, the wall section has woody vegetative growth between stones.		
Recommendations		
All voids should be replaced with similar stones. Mortar should be placed between the joints, where possible, to bind the stones together and to prevent seepage to/from the canal. Existing stones that are not flush with the wall surface should be repointed. All vegetation should be removed where possible. If removing the root structures would negatively impact the structural stability of the wall, then the vegetation should be treated instead to prevent future growth.

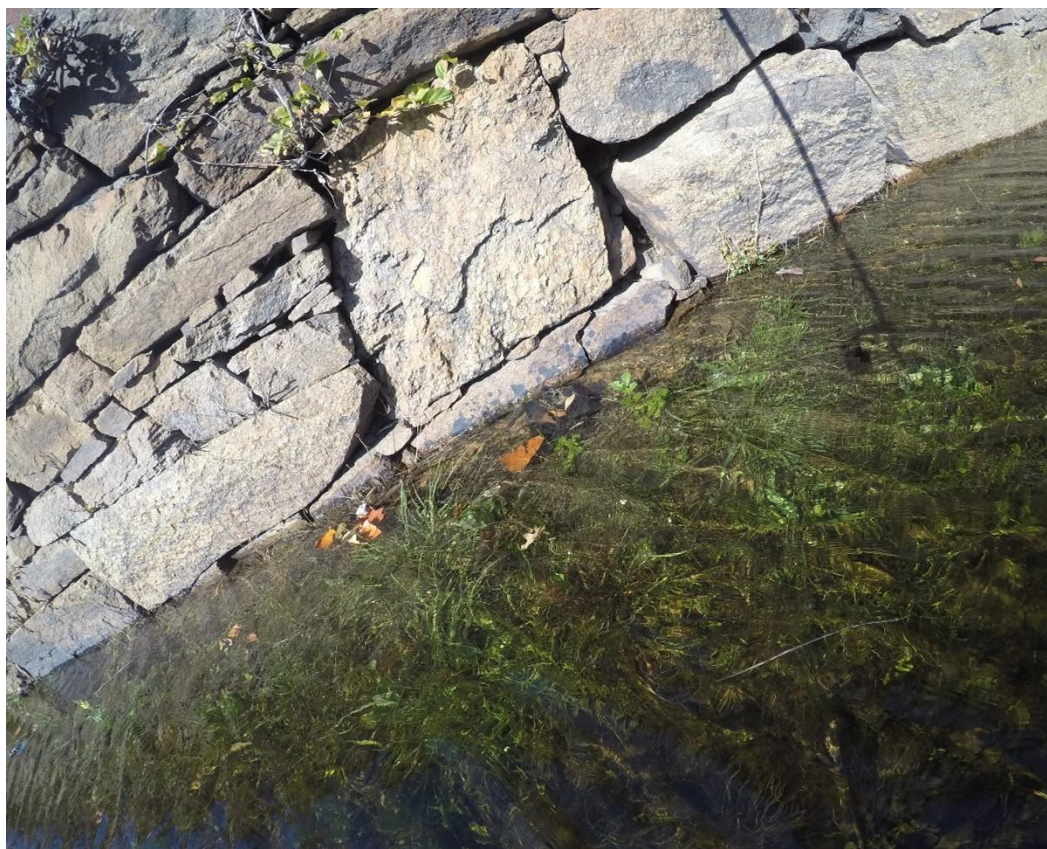
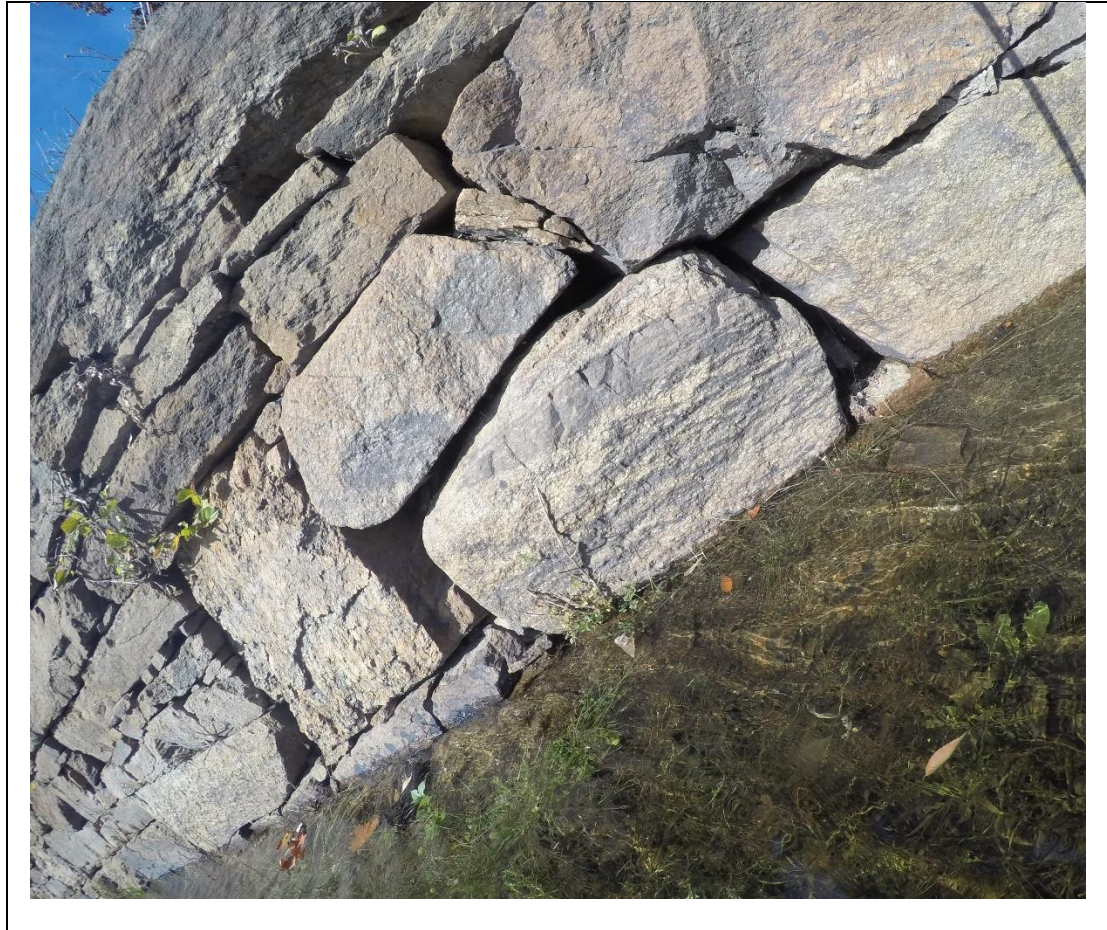
Wall Section	Station	Risk Level
NN7	4+70 to 5+50	2
Observations		
This wall section is comprised of dry-laid stone. This wall section is noted to have large areas of missing stones in various locations. Additionally, the crest of the wall is uneven and does not appear to be plumb with the rest of the wall. This is caused by areas of overhanging stone along the crest that do not form a flush face with the rest of the wall section. Also, the wall section has woody vegetative growth between stones.		
Recommendations		
All voids should be replaced with similar stones. Mortar should be placed between the joints, where possible, to bind the stones together and to prevent seepage to/from the canal. Existing stones that are not flush with the wall surface should be repointed. All vegetation should be removed where possible. If removing the root structures would negatively impact the structural stability of the wall, then the vegetation should be treated instead to prevent future growth.

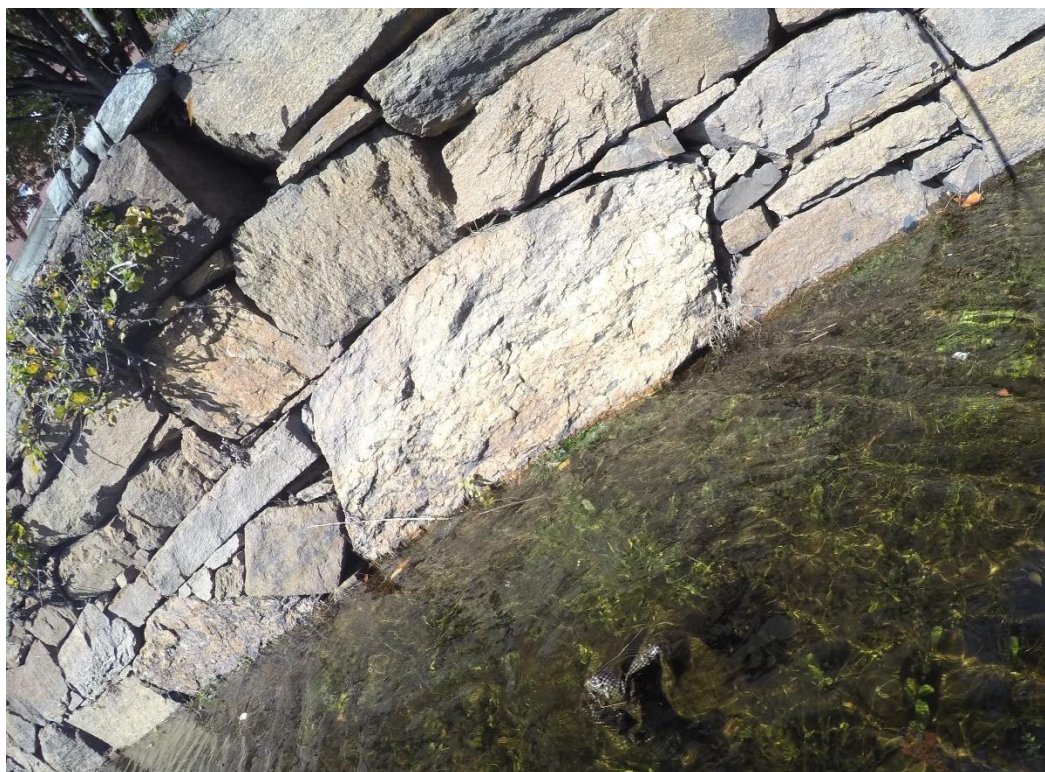
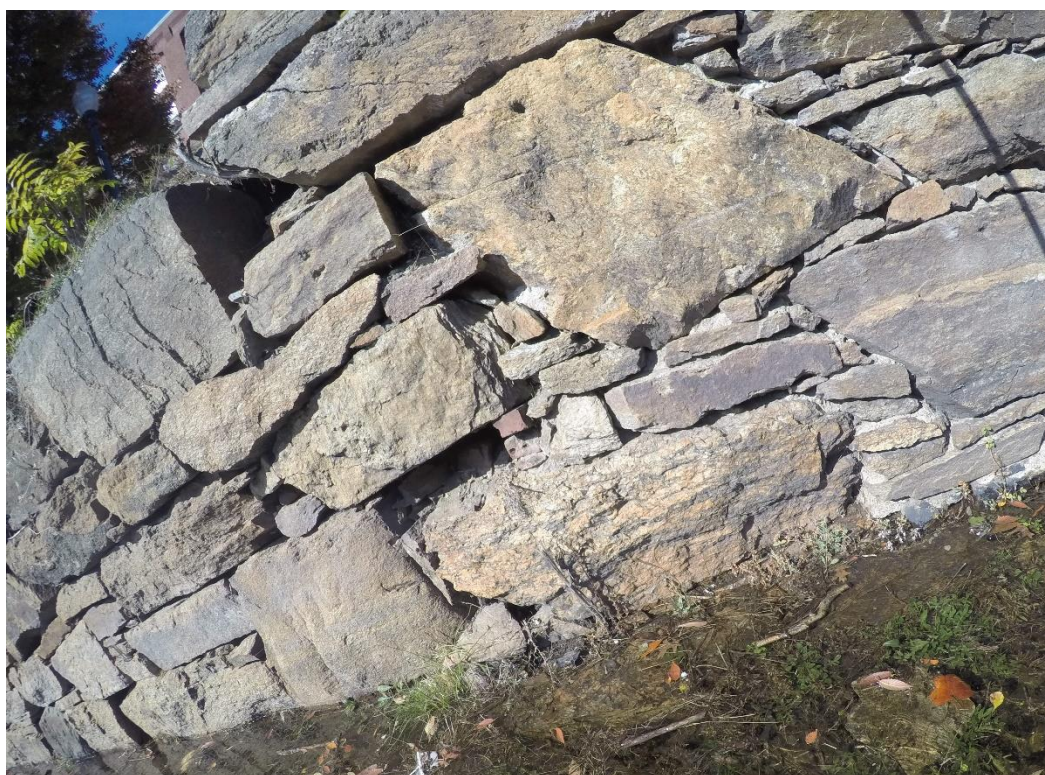
Wall Section	Station	Risk Level
NN8	5+50 to 6+05	2
Observations		
This wall section is comprised of dry-laid stone. There are some minor areas with mortared joints, but this is limited to certain joints or locations rather than major portions of the wall section. This wall section is noted to have large areas of missing stones in various locations. Additionally, the crest of the wall is uneven and does not appear to be plumb with the rest of the wall. This is caused by areas of overhanging stone along the crest that do not form a flush face with the rest of the wall section. Also, the wall section has woody vegetative growth between stones.		
Recommendations		
All voids should be replaced with similar stones. Mortar should be placed between the joints, where possible, to bind the stones together and to prevent seepage to/from the canal. Existing stones that are not flush with the wall surface should be repointed. All vegetation should be removed where possible. If removing the root structures would negatively impact the structural stability of the wall, then the vegetation should be treated instead to prevent future growth.

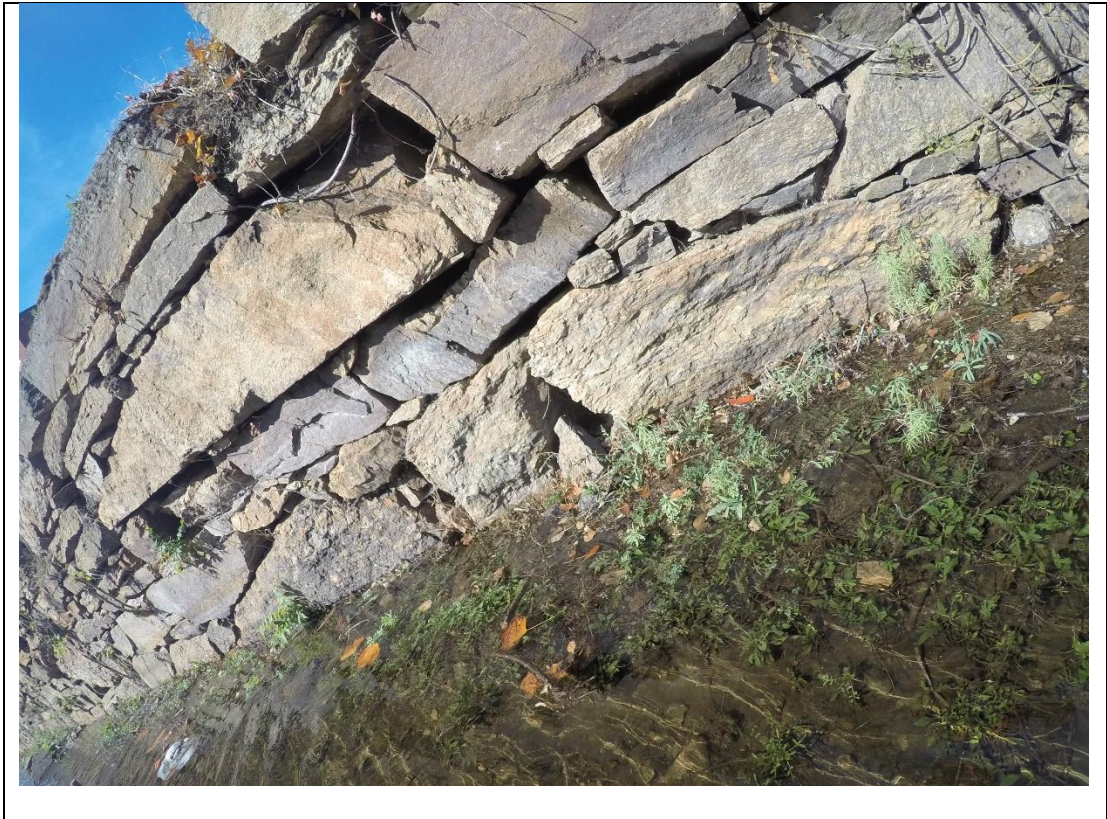
Wall Section	Station	Risk Level
NN11	6+80 to 10+50	2
Observations		
This wall section is comprised of dry-laid stone. This wall section is noted to have large areas of missing stones in various locations. Additionally, the crest of the wall is uneven, likely from erosion of the soils topping the crest, and does not appear to be plumb with the rest of the wall. Also, the wall section has woody vegetative growth between stones.		
Recommendations		
All voids should be replaced with similar stones. Mortar should be placed between the joints, where possible, to bind the stones together and to prevent seepage to/from the canal. Existing stones that are not flush with the wall surface should be repointed. All vegetation should be removed where possible. If removing the root structures would negatively impact the structural stability of the wall, then the vegetation should be treated instead to prevent future growth.

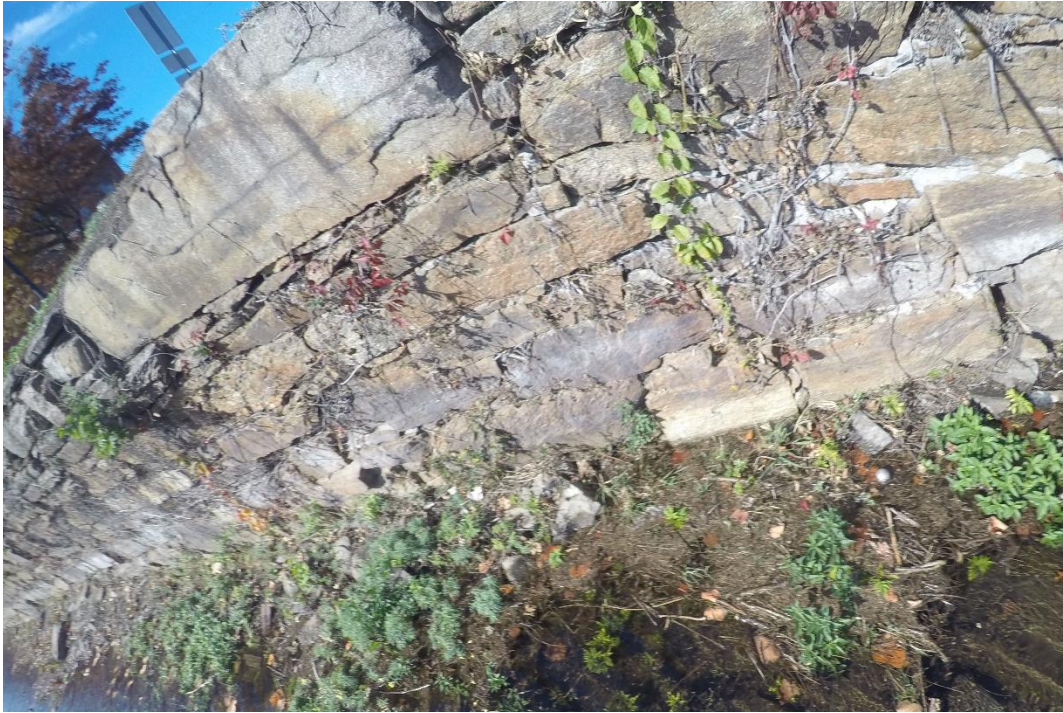
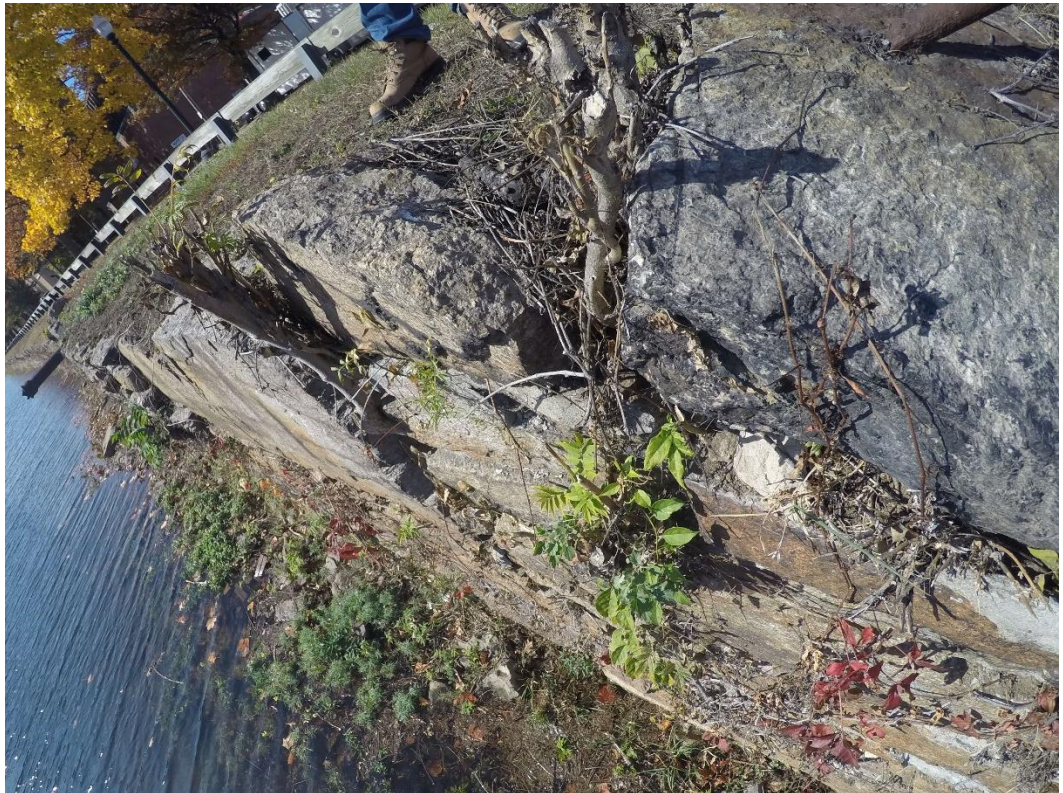
Wall Section	Station	Risk Level
NN15	14+90 to 17+20	2
Observations		
This wall section is comprised of dry-laid stone. There are some minor areas with mortared joints, but this is limited to certain joints or locations rather than major portions of the wall section. This wall section is noted to have large areas of missing stones in various locations. Additionally, the crest of the wall is uneven and does not appear to be plumb with the rest of the wall. This appears to be due to erosion forces behind the crest stones. Also, the wall section has woody vegetative growth between stones and a large series of viny growth.		
Recommendations		
All voids should be replaced with similar stones. Mortar should be placed between the joints, where possible, to bind the stones together and to prevent seepage to/from the canal. Existing stones that are not flush with the wall surface should be repointed. All vegetation should be removed where possible. If removing the root structures would negatively impact the structural stability of the wall, then the vegetation should be treated instead to prevent future growth.

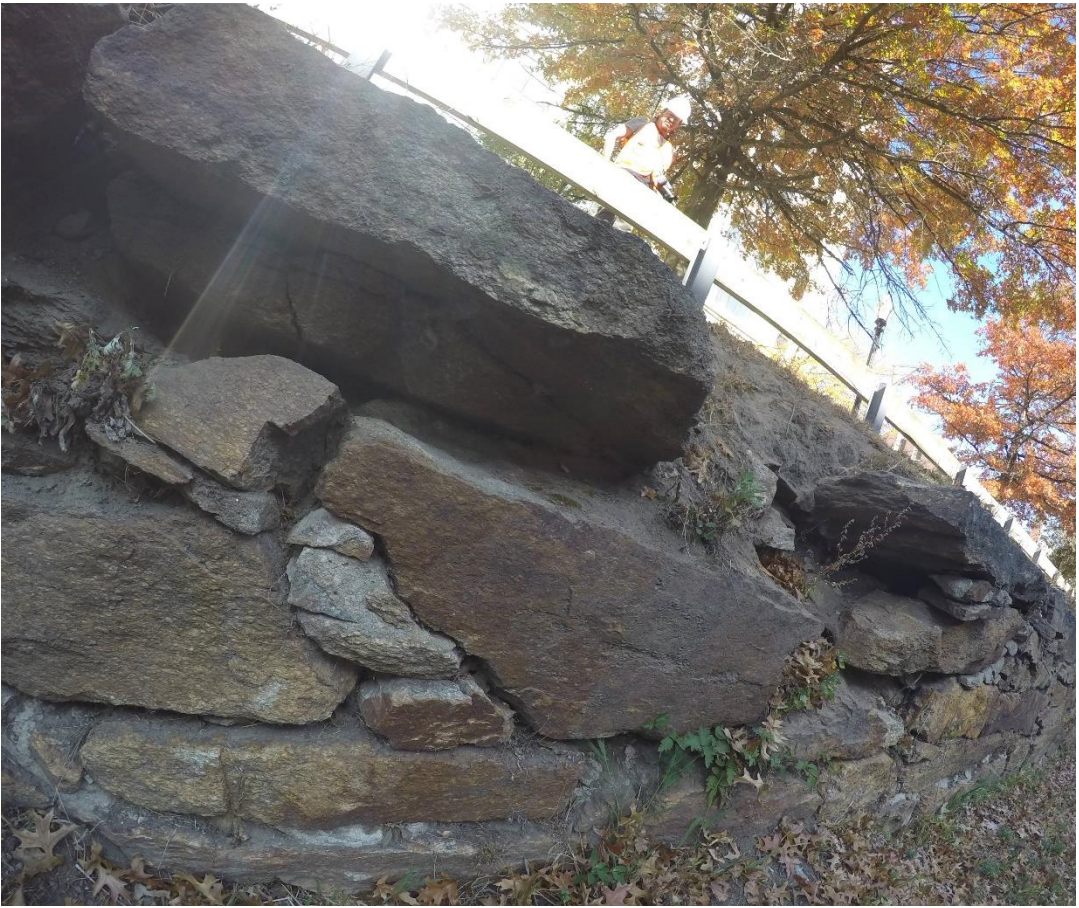
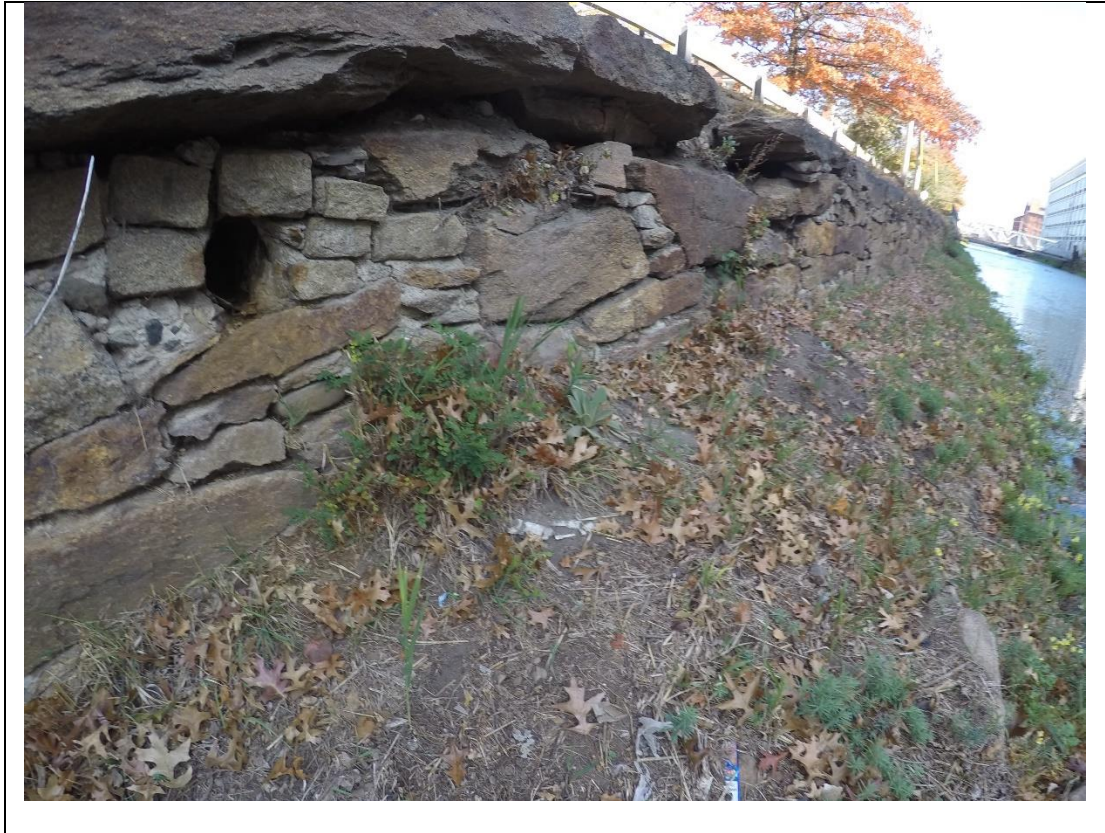
Wall Section	Station	Risk Level
NN22	30+10 to 31+35	2
Observations		
<p>This wall section is comprised of dry-laid stone. There are some minor areas with mortared joints, but this is limited to certain joints or locations rather than major portions of the wall section. This wall section is noted to have large areas of missing stones in various locations, including the crest. This has led to the crest of the wall being uneven. Furthermore, the joints between cap stones are relatively large in areas which has led to heavy erosion of the soil materials on top of and behind the wall to fill voids with soil. Heavy erosion under the cap stones has led to voids and the face of the wall not being flush. Also, the wall section has slight woody vegetative growth between stones.</p>		
Recommendations		
<p>All voids should be replaced with similar stones. Mortar should be placed between the joints, where possible, to bind the stones together and to prevent seepage to/from the canal. Existing stones that are not flush with the wall surface should be repointed. All displaced soil should be removed from the capstone joints. If capstone joint openings are excessive, additional capstones should be added and the existing capstones shifted to have a limited joint opening. These joints should be mortared to prevent future surface erosion and vegetative growth through the joint. All vegetation should be removed where possible. If removing the root structures would negatively impact the structural stability of the wall, then the vegetation should be treated instead to prevent future growth.</p>

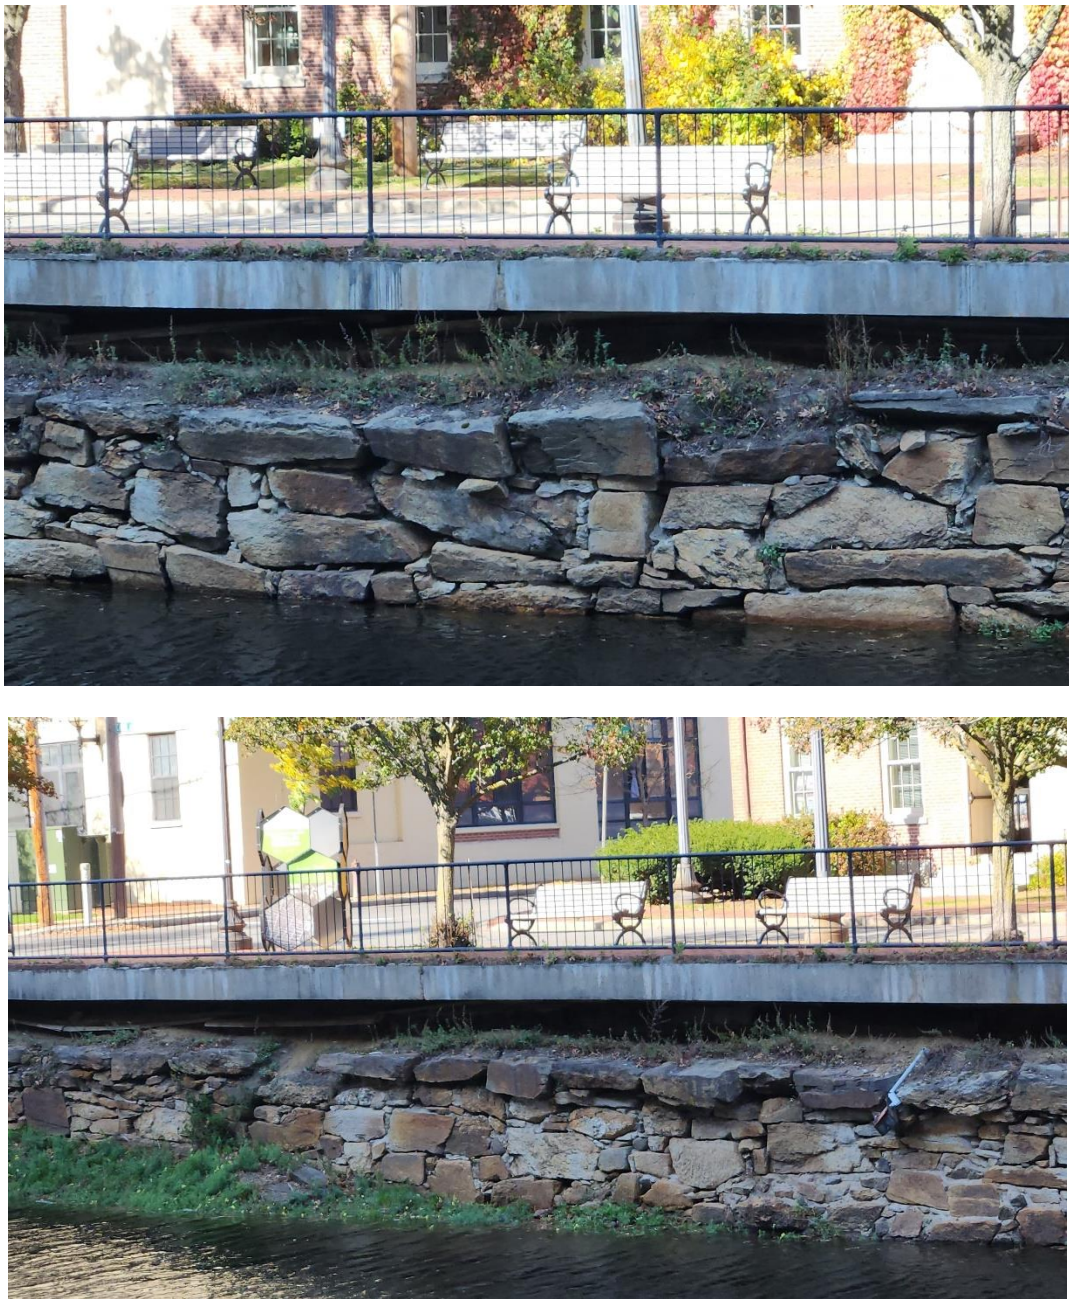
Wall Section	Station	Risk Level
NN23	31+35 to 33+00	1
Observations		
<p>This wall section is comprised of dry-laid stone. There are some minor areas with mortared joints, but this is limited to certain joints or locations rather than major portions of the wall section. The top of the wall section is covered by a large, concrete public observation deck with benches and a brick face. The crest and stones near the top of the wall appear to be leaning heavily into the canal, most likely caused by significant erosion of soils behind the canal wall and under the observation deck. It is noted there is no grass cover or material cover to prevent erosion under the observation deck. Additionally, this wall section is noted to have large areas of missing stones in various locations, including the crest.</p>		
Recommendations		
<p>The wall should be rebuilt with the same or similar materials and joints should be mortared to prevent erosion of soils from under the overhang. Essex is working with the Massachusetts Department of Conservation and Recreation and Lawrence Redevelopment Authority to coordinate repairs in 2026, which will require removal of the observation deck.</p>

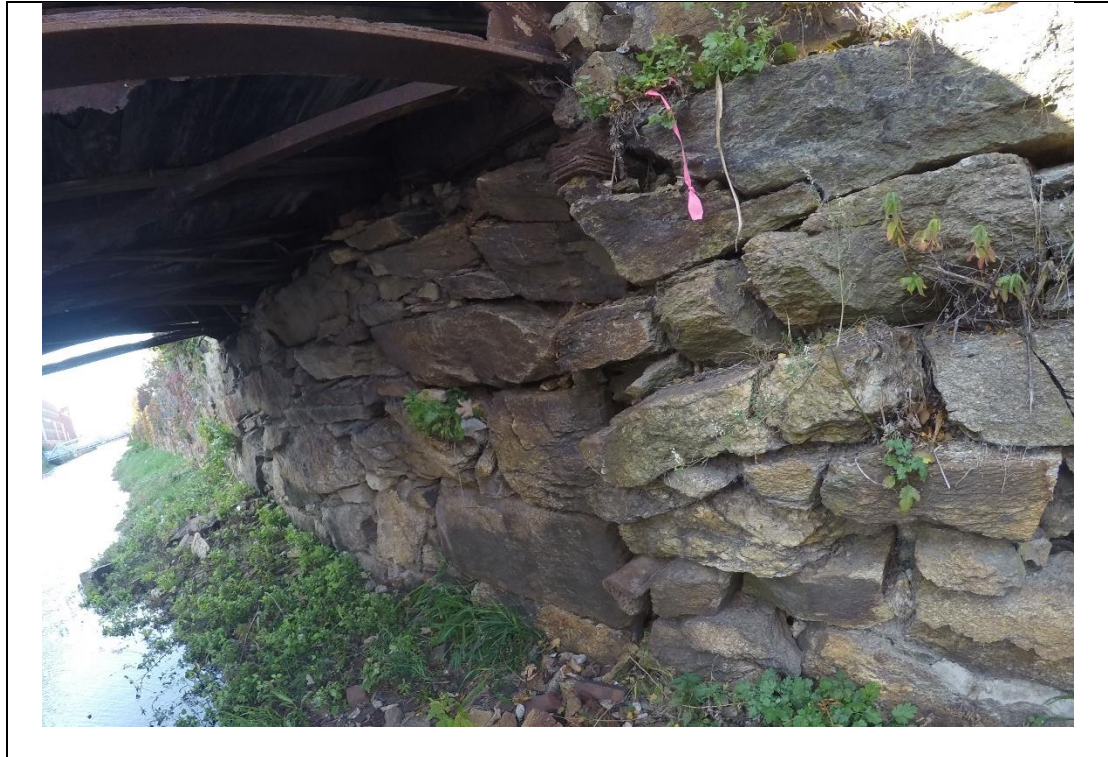
Wall Section	Station	Risk Level
NN27	40+50 to 40+90	2
Observations		
This wall section is comprised of dry-laid stone. However, the wall section is positioned under the old Pemberton Mill Bridge, which is blocked from usage by concrete jersey barriers. The stones of the wall section do not appear stable or properly plumb. The stones appear to be shifting and do not have a flush face. Unlike many of the bridges on the Lawrence canal system, there does not appear to be a solid brick, concrete, or mortared-stone abutment for the bridge to rest on, instead resting directly on the dry-laid stone.		
Recommendations		
The wall section below the bridge should be rebuilt in-kind with similar stone. The stones should provide a flush, uniform face on the canal side and joints should be mortared to add stability and prevent erosion/seepage from the abutment.

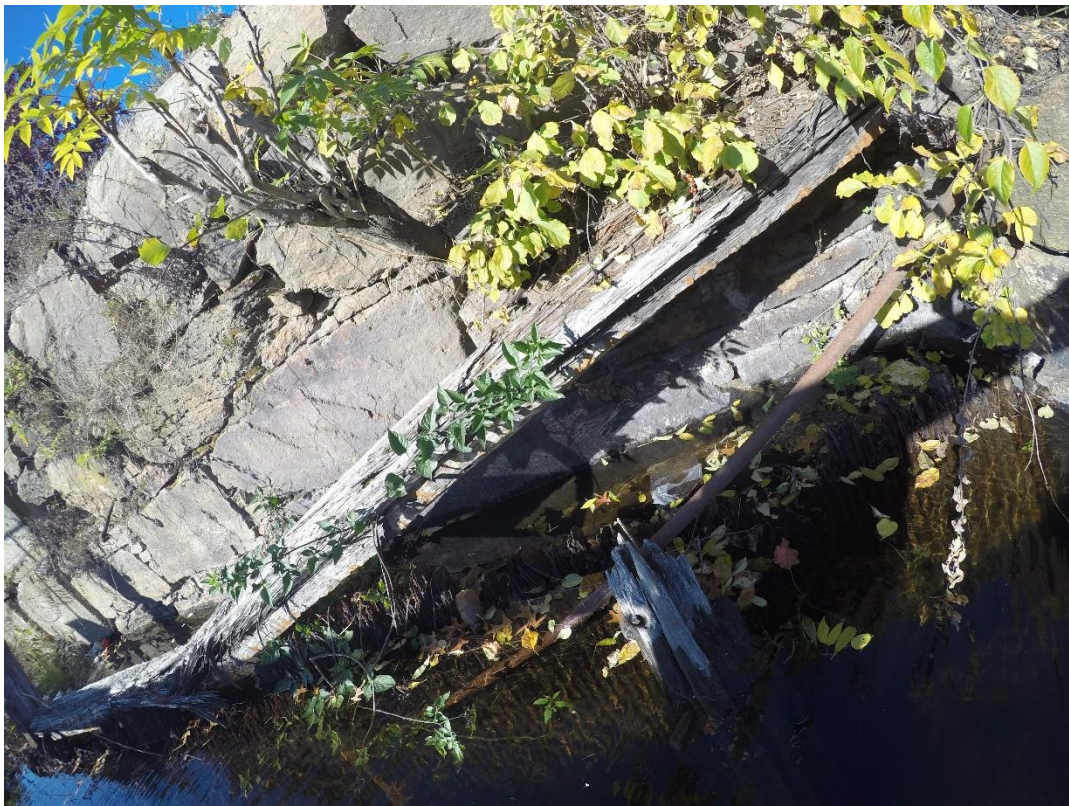
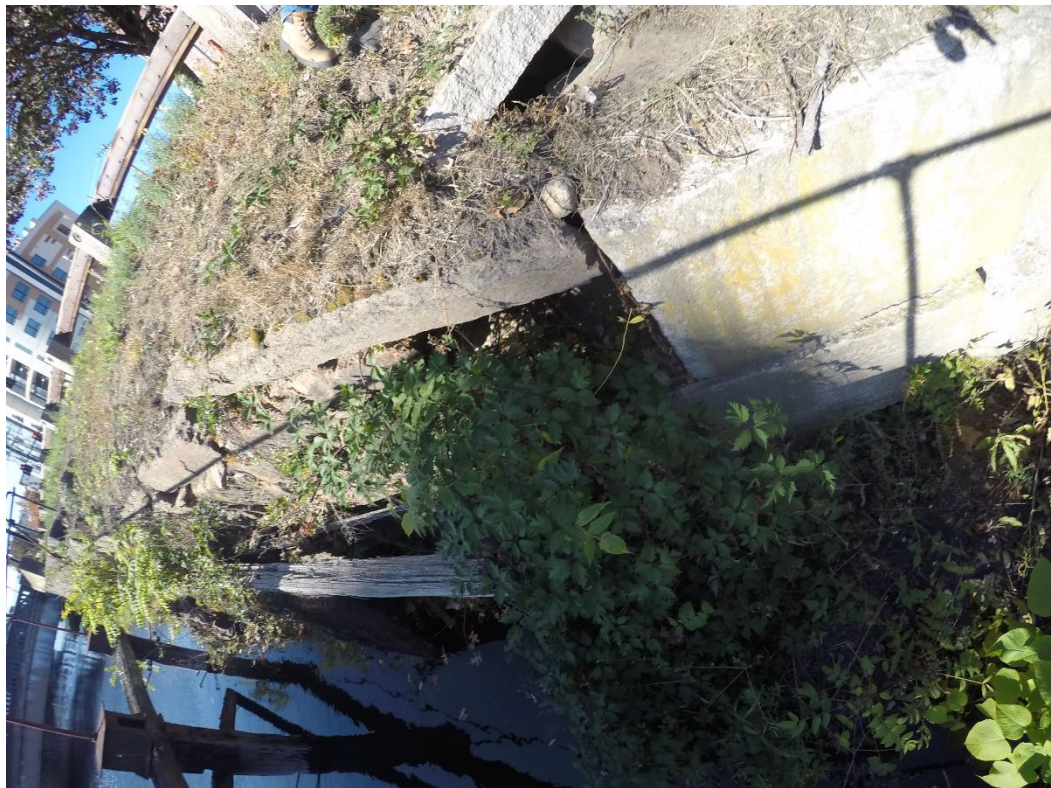
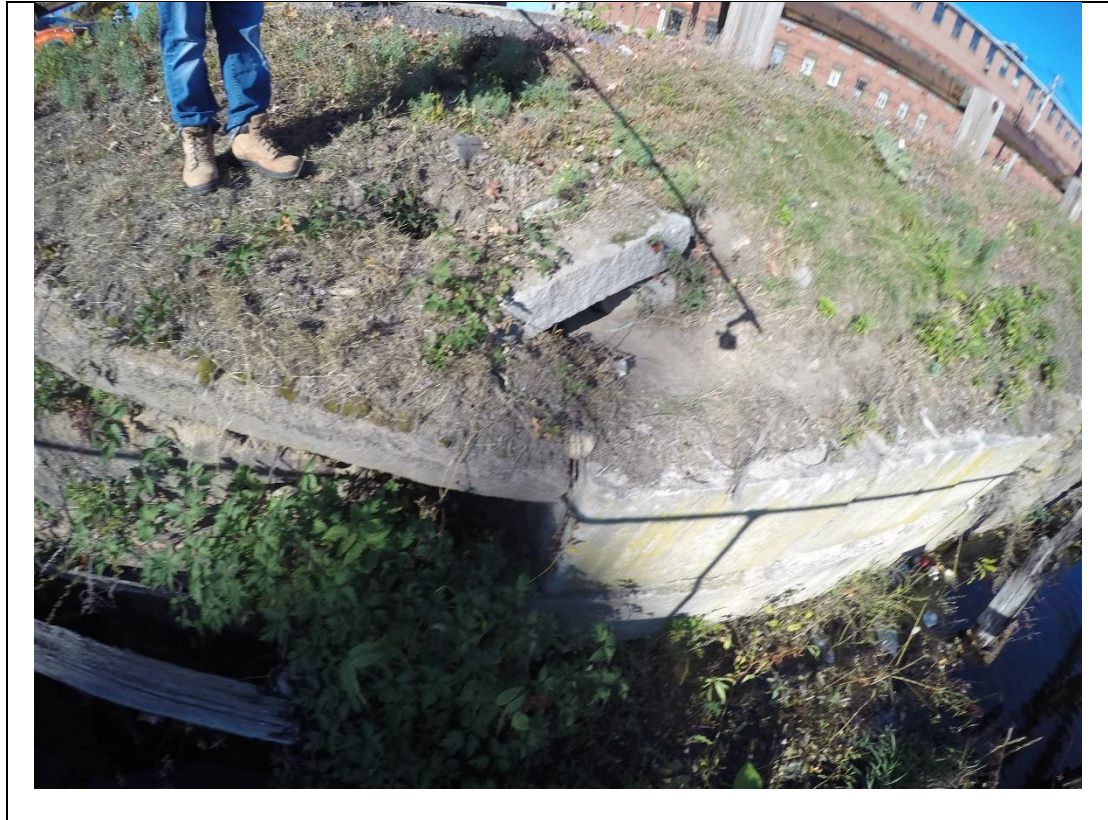
Wall Section	Station	Risk Level
NN35	46+50 to 47+20	1
Observations		
<p>This wall section is generally comprised of dry-laid stone (where visible) and an abandoned intake structure. A portion of the wall section is blocked from viewing due to an old intake structure. Of the visible portions of the wall section, the stones do not appear properly pointed, with no flush face. Portions of the visible stones do not appear plumb. Several stones have been weathered significantly. The crest of the wall section is non-uniform and appears to be partially collapsing into the intake structure where there are voids or erosion. Additionally, several stones along the crest have shifted or are missing entirely. The abandoned utility intake structure is in a state of heavy disrepair. The steel trashracks have corroded to near non-existence. The timber support structure is cracked and rotted. Steel bars supporting the structure are anchored to the stone wall section and pulling the stones with it as it leans into the canal. The entire intake structure and wall section are covered in vegetation.</p>

Recommendations		
<p>The wall section should be rebuilt in-kind with similar stone. The stones should provide a flush, uniform face on the canal side and joints should be mortared to add stability and prevent erosion/seepage. The opening of the intake should be filled with stone and mortared to prevent seepage between the canal and the adjoining soil. The vegetation should be removed.</p> <p>The abandoned intake structure should be repaired and regularly maintained by the associated mill owner. The mill owner should consider removal of the intake structure. Maintenance and removal of unused intakes is the responsibility of the associated mill owner.</p>

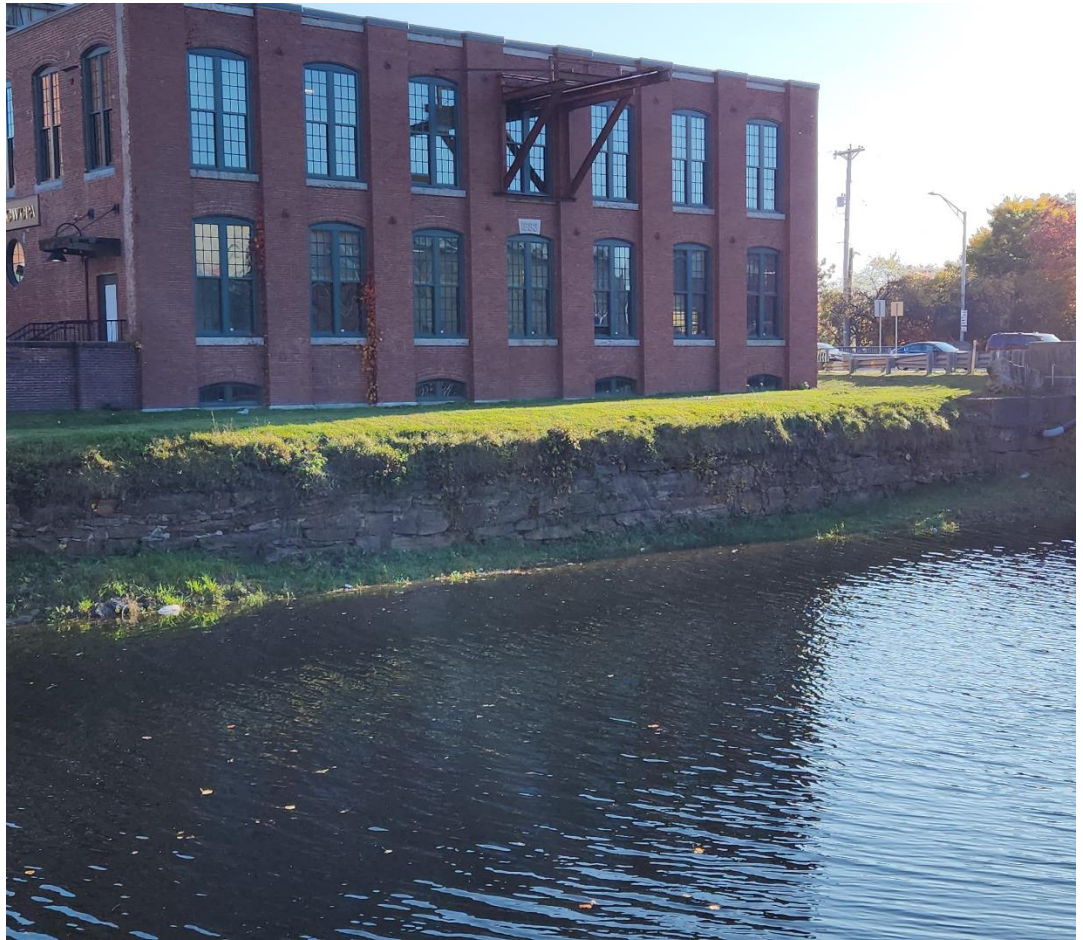
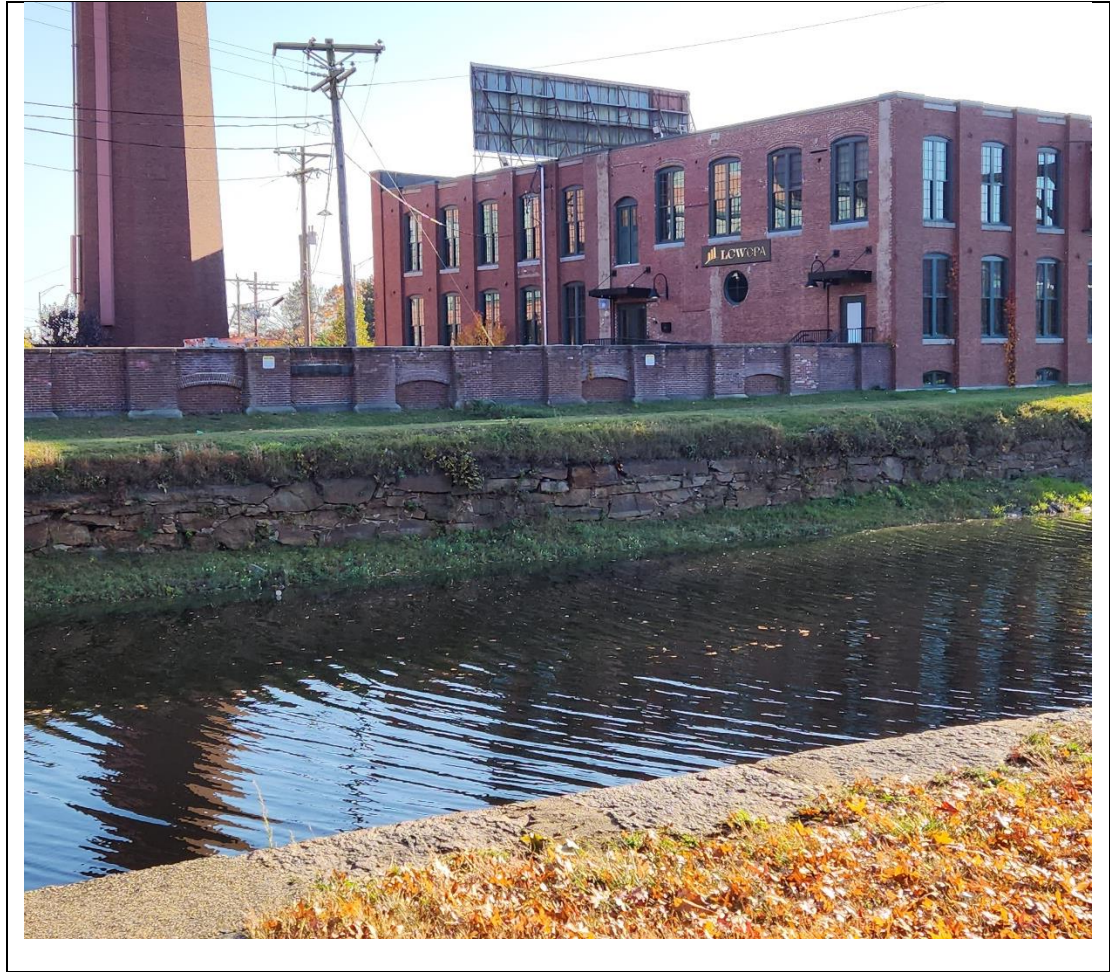
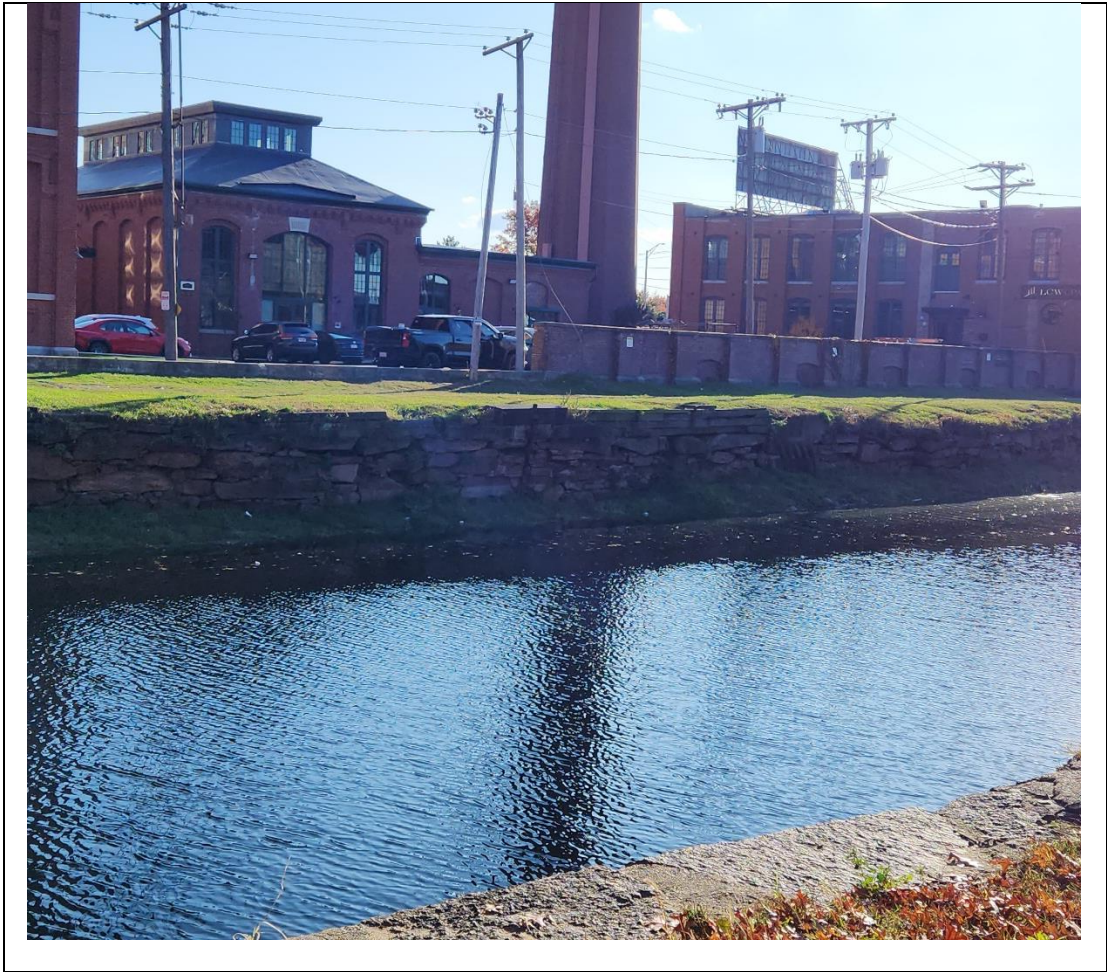
Wall Section	Station	Risk Level
NS10	19+25 to 23+75	1
Observations		
This wall section is comprised of dry-laid stone. The wall appears to be unstable and is leaning into the canal. Some of the capstones have already collapsed into the canal. Additionally, there are various gaps and voids noted throughout this entire section.		
Recommendations		
The wall should be re-built in kind with similar stones. Stones should be mortared between joints.
