Condition Assessment of Historic Properties and Associated Canal System

Lawrence Hydroelectric Project (FERC
No. 2800)

May 6, 2025

Essex Company, LLC
Manchester, New Hampshire

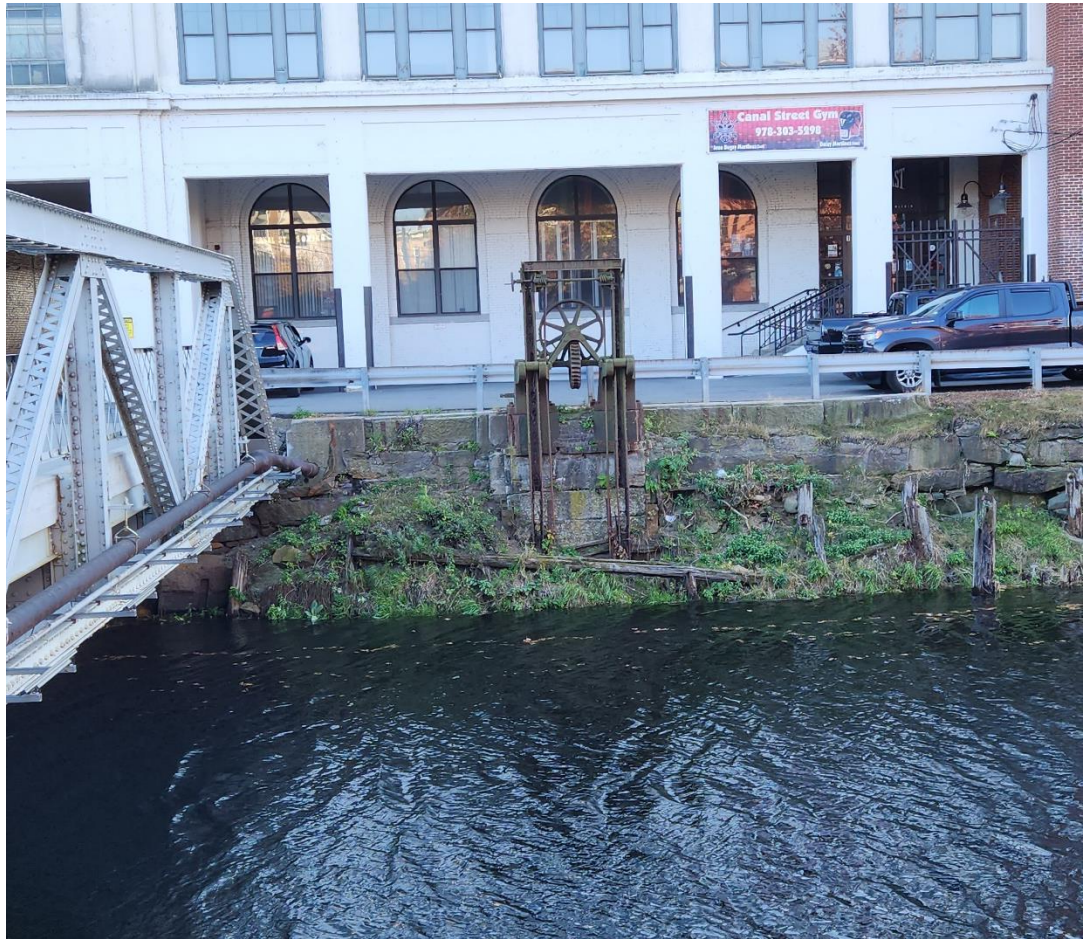
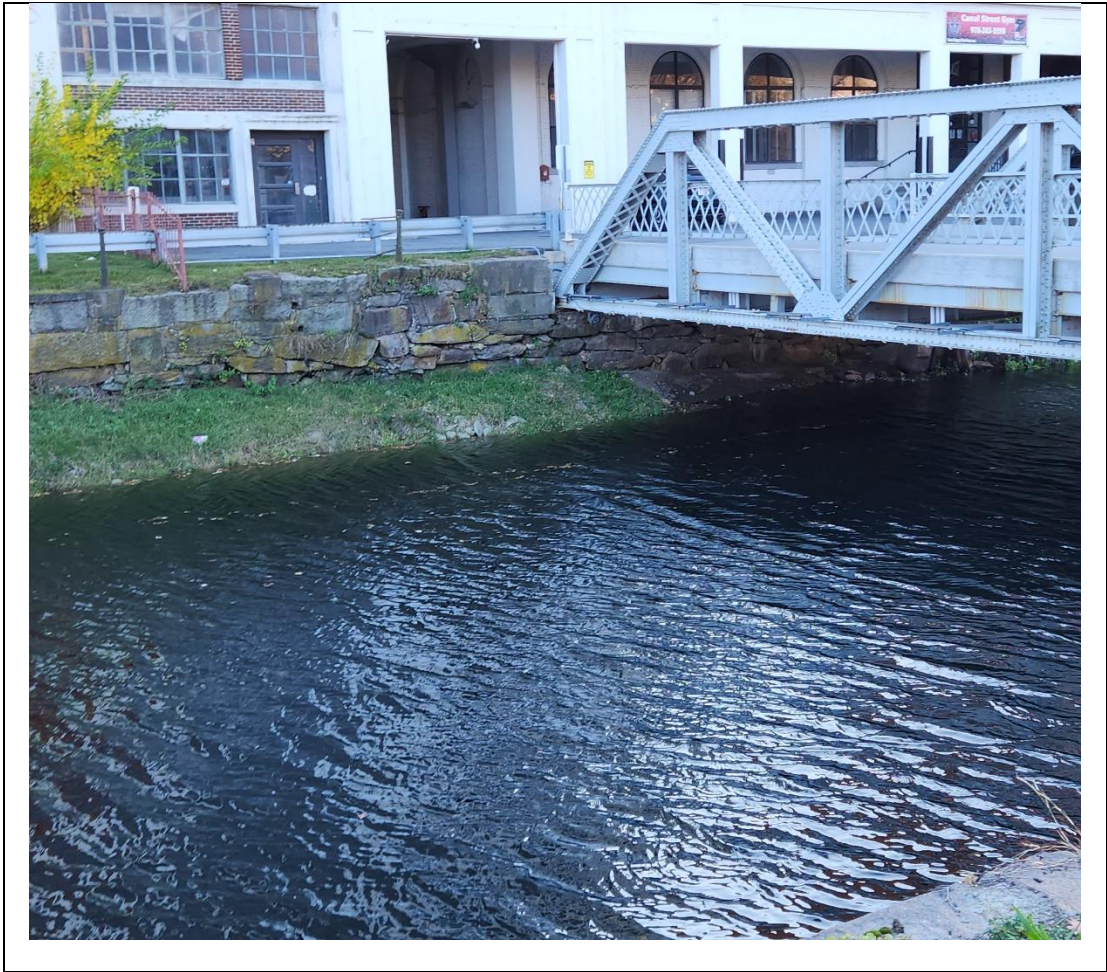
Wall Section	Station	Risk Level
NS20	34+00 to 35+25	2
Observations		
This wall section is comprised of dry-laid stone. Additionally, portions of the wall section do not appear plumb. There are several voids that are moderate in size, and several stones have visible wear. An abandoned intake structure is in a state of disrepair. The wall section is covered in heavy vegetation, though the vegetation does not appear significantly woody or with deep root structures.		
Recommendations		
The wall should be re-built in kind with similar stones. The old intake structure should be left in place and either rehabilitated or preserved. Maintenance of unused intakes is the responsibility of the associated mill owner. The opening behind the gate structure should be filled with concrete if the gate structure is not planned to be opened.

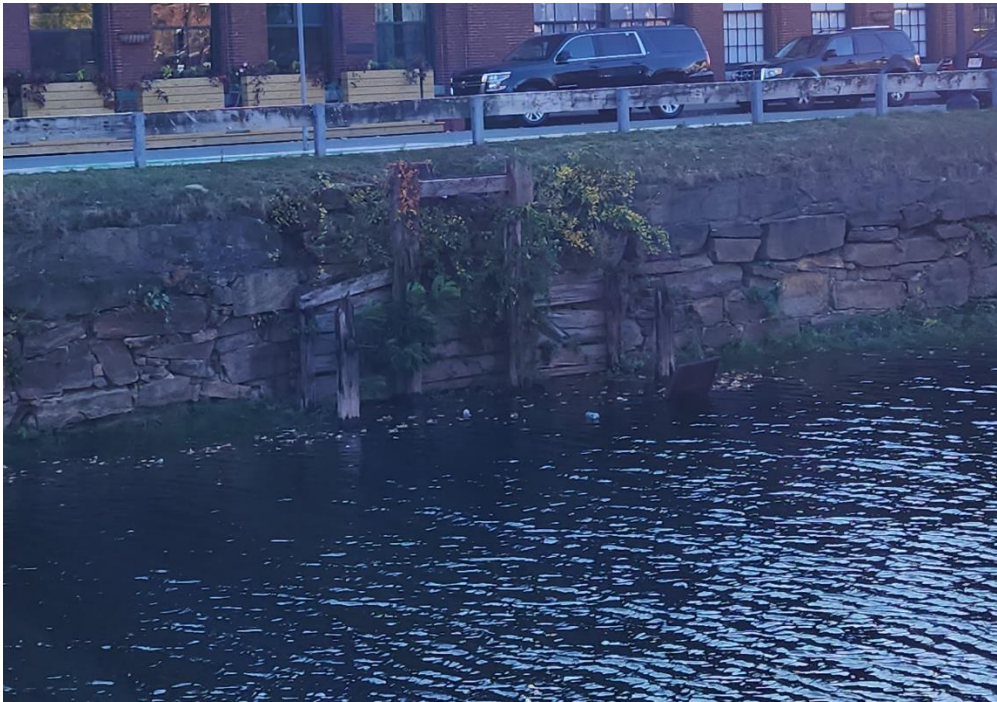
Wall Section	Station	Risk Level
NS28	48+10 to 48+30	1
Observations		
This wall section is comprised of dry-laid stone. Stones have shifted along this section. Stones along the crest have partially collapsed into the canal. The remaining stonework is leaning and does not appear stable. The wooden intake gate structure is significantly deteriorated.		
Recommendations		
The wall section should be rebuilt in kind using similar stones. Joints should be mortared. The intake structure should be preserved, rehabilitated, or restored. The opening behind the gate should be filled with similar stone to the wall and mortared, to prevent seepage through the gate structure.

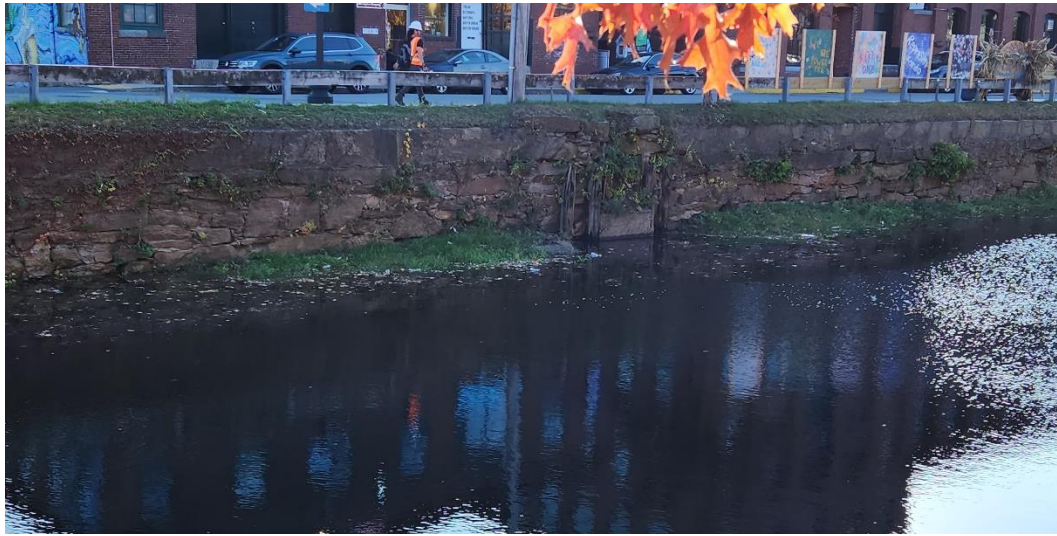
Wall Section	Station	Risk Level
NS30	49+35 to 51+40	2
Observations		
This wall section is comprised of dry-laid stone. The wall section has several large voids and dislodged stones. The wall section appears to be leaning into the canal, as evidenced by the heavy erosion of soil and sod on top of the wall crest. A portion of the wall includes concrete. This abandoned concrete has significant undermining.		
Recommendations		
The wall section should be rebuilt in kind using similar stones. Joints should be mortared.

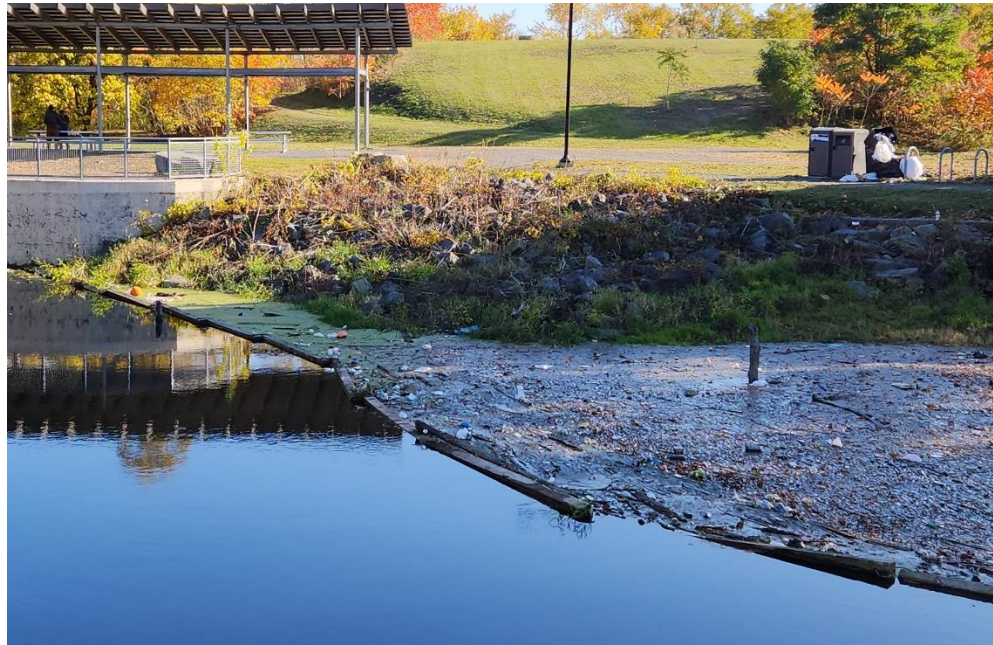
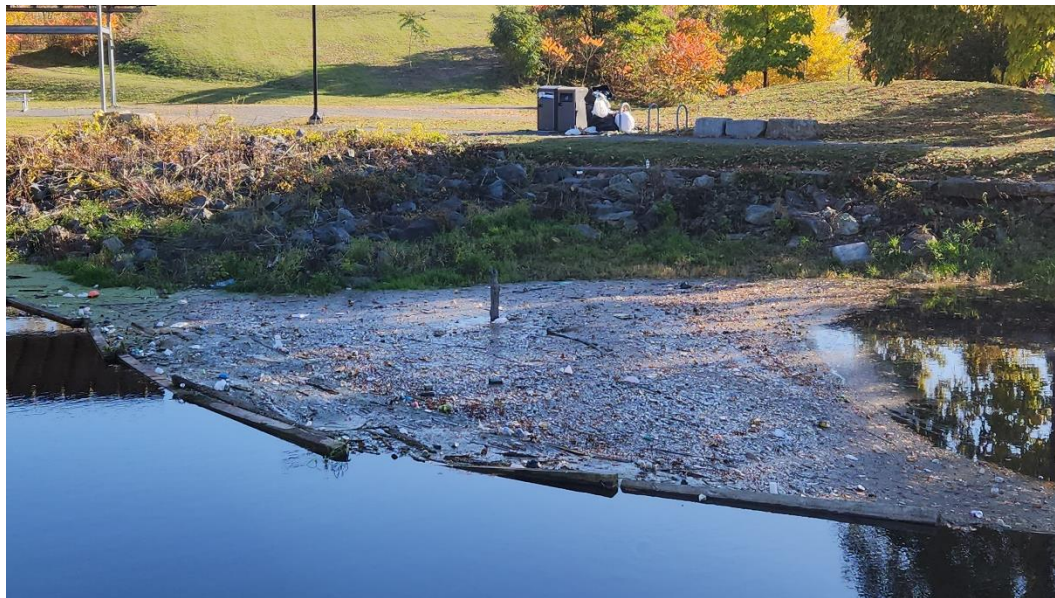
Wall Section	Station	Risk Level
NS34	60+15 to 60+80	2
Observations		
This wall section is comprised of a sloped earthen embankment with a dry-laid stone cap. The earthen embankment is covered in minor grassy and weedy vegetation. The slope appears to generally be maintained. However, the rip-rap is not spread evenly and has gaps between stones. Additionally, the stone wall cap is out of plumb and does not appear stable.		
Recommendations		
The embankment slope should be monitored for any future deterioration. Its surface should be kept clear of vegetation growing between rip-rap stones, and the rip-rap should be evenly placed over its entire surface. Gaps within the rip-rap should be filled with stone. The stone wall cap should be repointed. New stones should be fitted where there are voids. All joints between the capstones should be mortared.

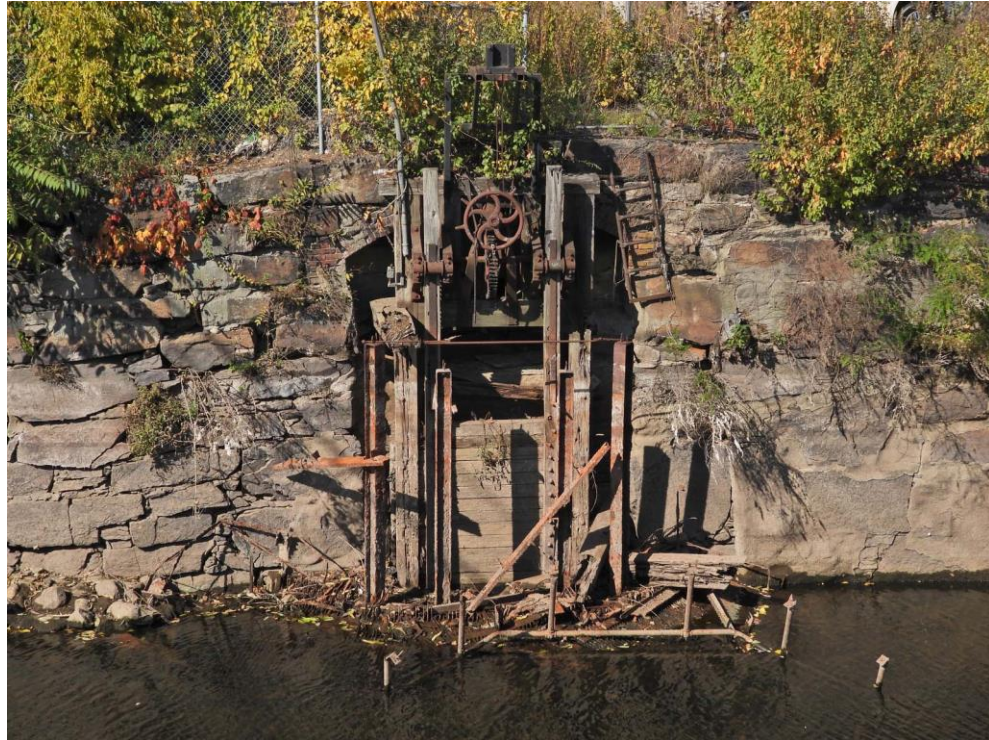
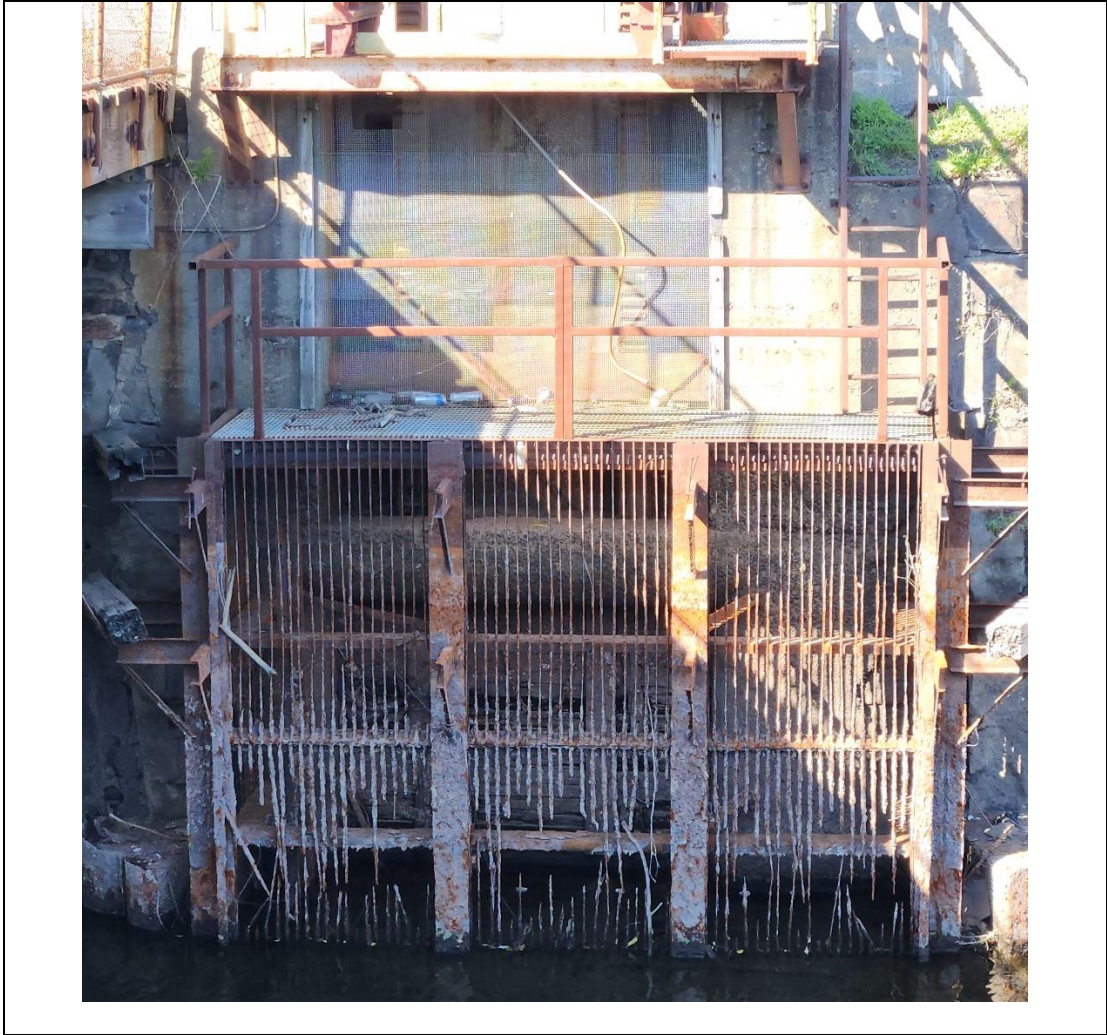
Wall Section	Station	Risk Level
SN5	5+90 to 7+40	2
Observations		
This wall section is generally comprised of dry-laid stone (though a portion of the wall has been repaired and re-mortared). Large voids of missing stone are noted sporadically along the length of the wall. This wall section also includes two old gate intake structures. Both structures are in a state of heavy disrepair. This disrepair has led to the surrounding wall section being affected by the steel anchors/bolts for the various structural components, pulling the stones from the wall. Additionally, the wall section has several areas of vegetative growth; the crest, in particular, is covered in trees and shrubs, which may impact the structural stability of the wall due to root structures growing in cracks and voids between the stones. Portions of the wall face do not appear flush.		
Recommendations

The wall section face should be repointed so that the face is flush and plumb. Any voids should be filled with similar stones and joints between stones should be mortared like the previous repair work. The two old gate structures should be restored, rehabilitated, or preserved. Any openings from the gate structures should be filled with stones and mortared to prevent seepage. Maintenance and removal of unused intakes is the responsibility of the associated mill owner. All woody vegetation on the surface of the wall and the crest should be removed including brush and trees.

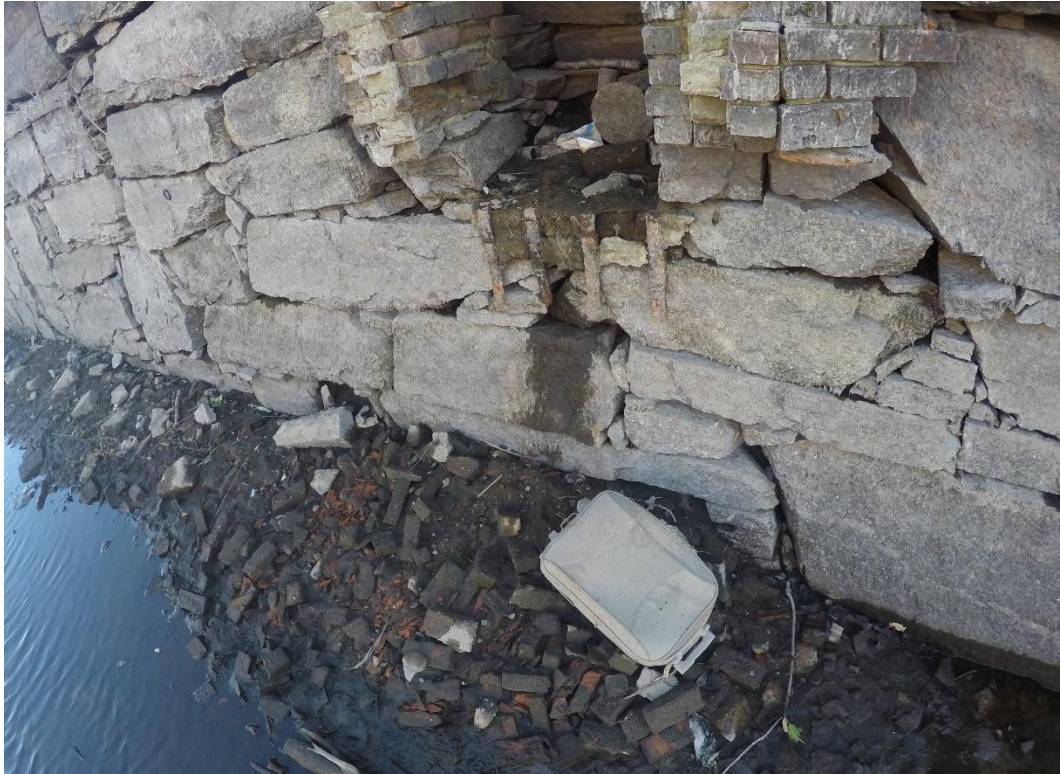
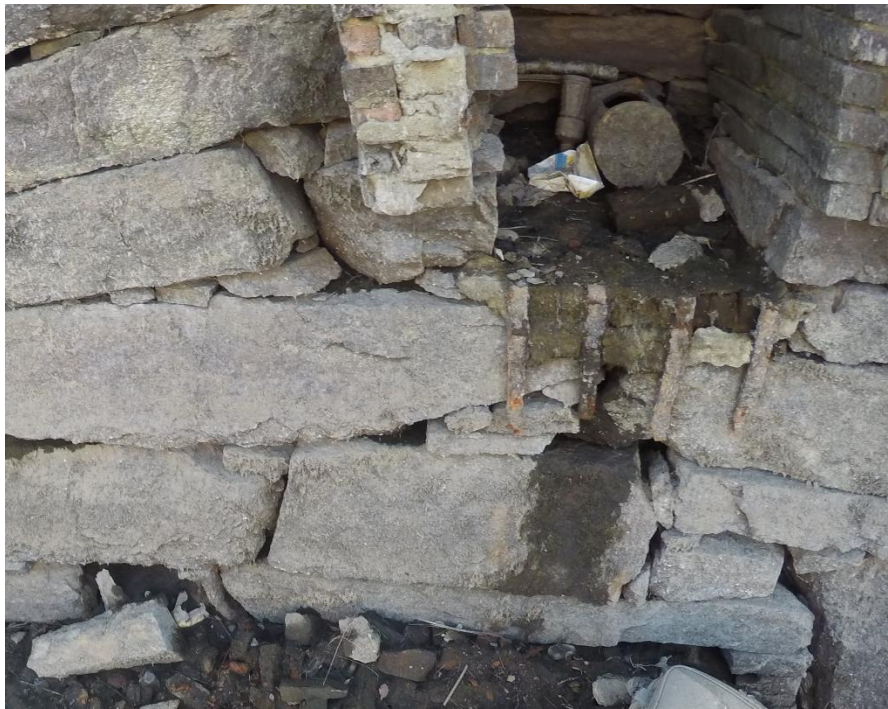
Wall Section	Station	Risk Level
SS11	15+10 to 15+40	2
Observations		
The bottom portion of the wall section is dry-laid stone and is in relatively good shape, despite various small voids. The upper portion of the wall section is a brick-and-mortar frame surrounding a pipe exit, creating a hollow void approximately 2-feet-wide by 4-feet-high with the pipe at its center. The pipe exit has been stubbed and capped. Seepage is noted around the interior of the void. The brick frame has shifted over time and, rather than in line with the wall face, has rotated approximately 45 degrees on one side and about 10 degrees on the other. Additionally, there is a sizable number of lost bricks within the framing, and some of the mortar holding the remaining bricks in place also appears to be missing.		
Recommendations		
The existing brick framing should be repointed, re-mortared, and added to for support of the structure around the sealed pipe. The rest of the opening surrounding the pipe should be filled with similar stone to the rest of the wall and mortared to prevent erosion and leakage and to add stability to the rest of the wall section.

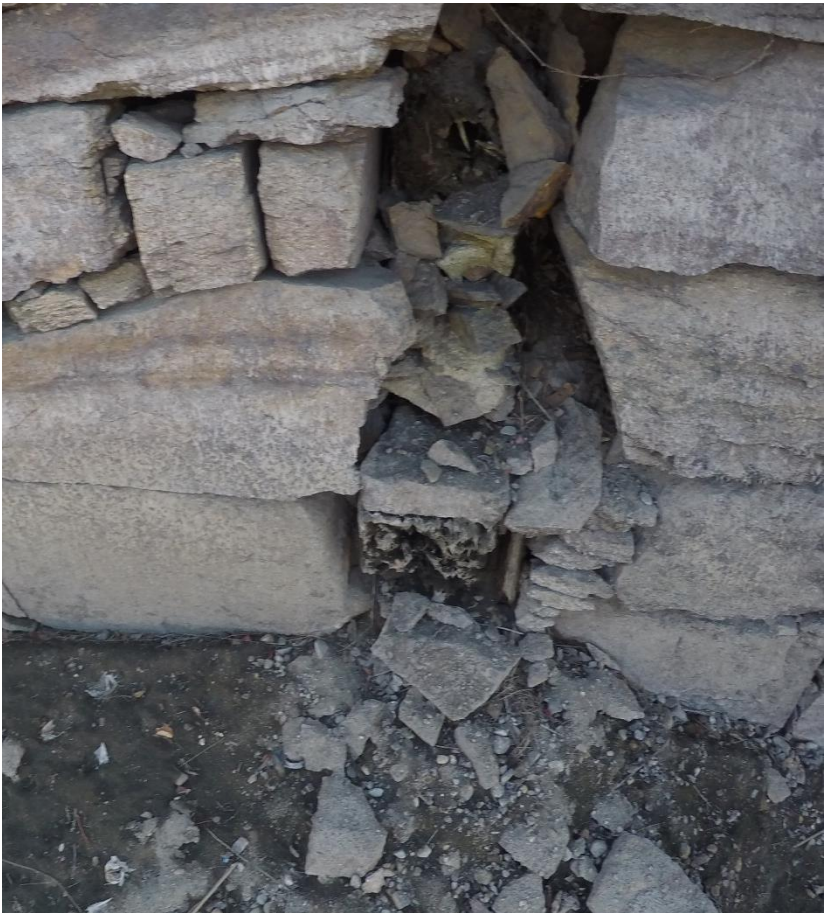
Wall Section	Station	Risk Level
SS13	17+25 to 17+50	1
Observations		
<p>This wall section is comprised of dry-laid stone. The stone, however, has numerous voids in this vicinity. Additionally, the wall appears to have been retrofitted for a discharge pipe and supported by steel framing at the base of the wall. The dry-laid stone in this area has collapsed, creating a void of approximately 18 inches wide for almost the full wall height. Loose stone can be seen surrounding the discharge pipe and the steel frame along the base of the wall. The only functional portions of the wall at this location are the cap stones. The discharge pipe entrance is visible, indicating it has not been filled in. Its purpose and current usage status is unknown.</p>		
Recommendations		
<p>Determine functionality of discharge pipe. If pipe is no longer active, completely seal with concrete cap. Fill void in wall with similar stone and mortar joints to prevent leakage from pipe and groundwater seepage in old voids.</p>
