Freshwater Mussel Habitat Assessment and Survey

Lawrence Project (FERC No. 2800)

Prepared For
Essex Company, LLC
A subsidiary of Patriot Hydro, LLC

April 2025

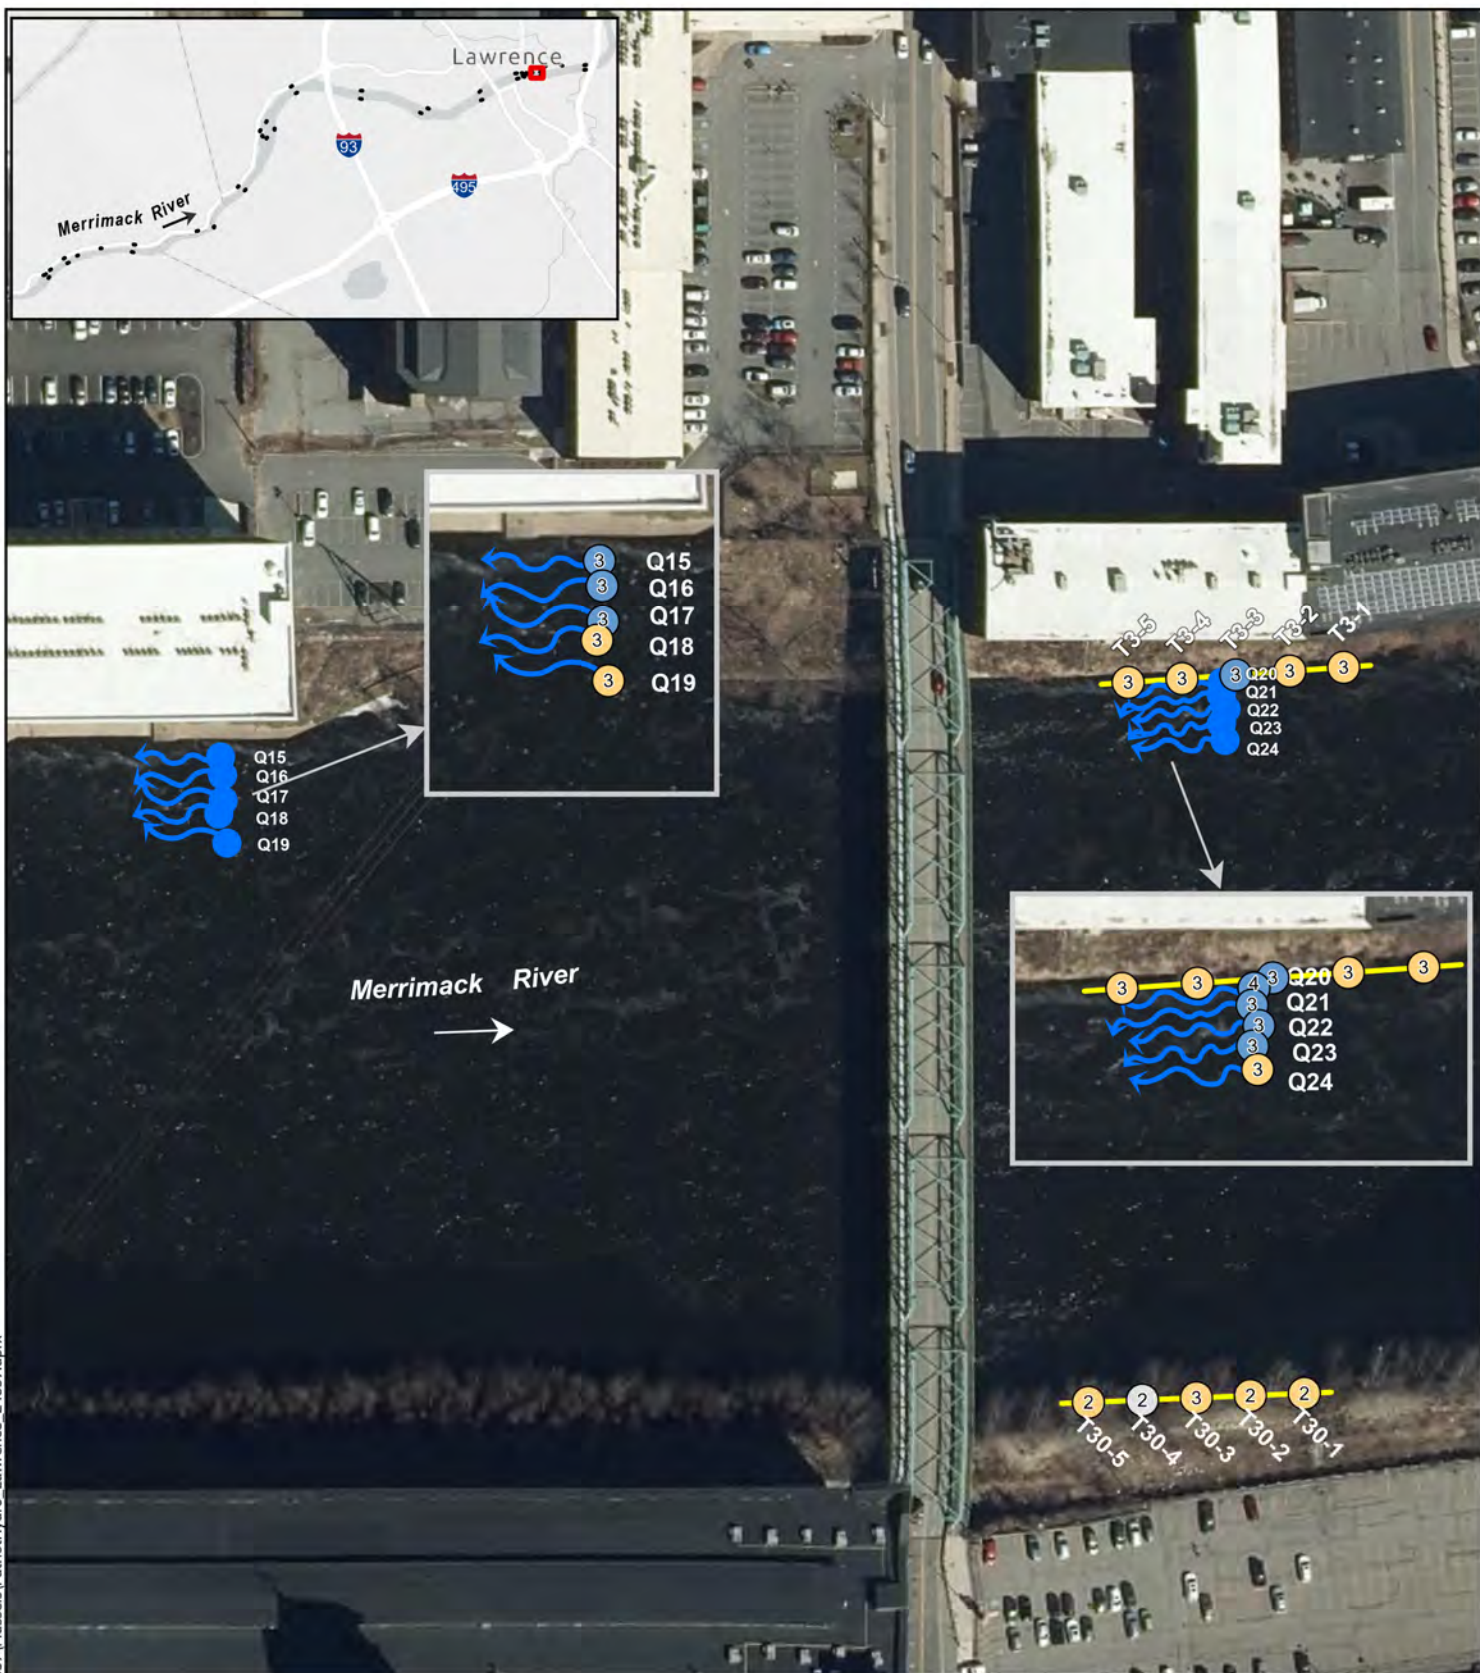
Appendix A - Figure 3
T3, T30 and Q15 - Q24
Live Unionids and Species Distribution

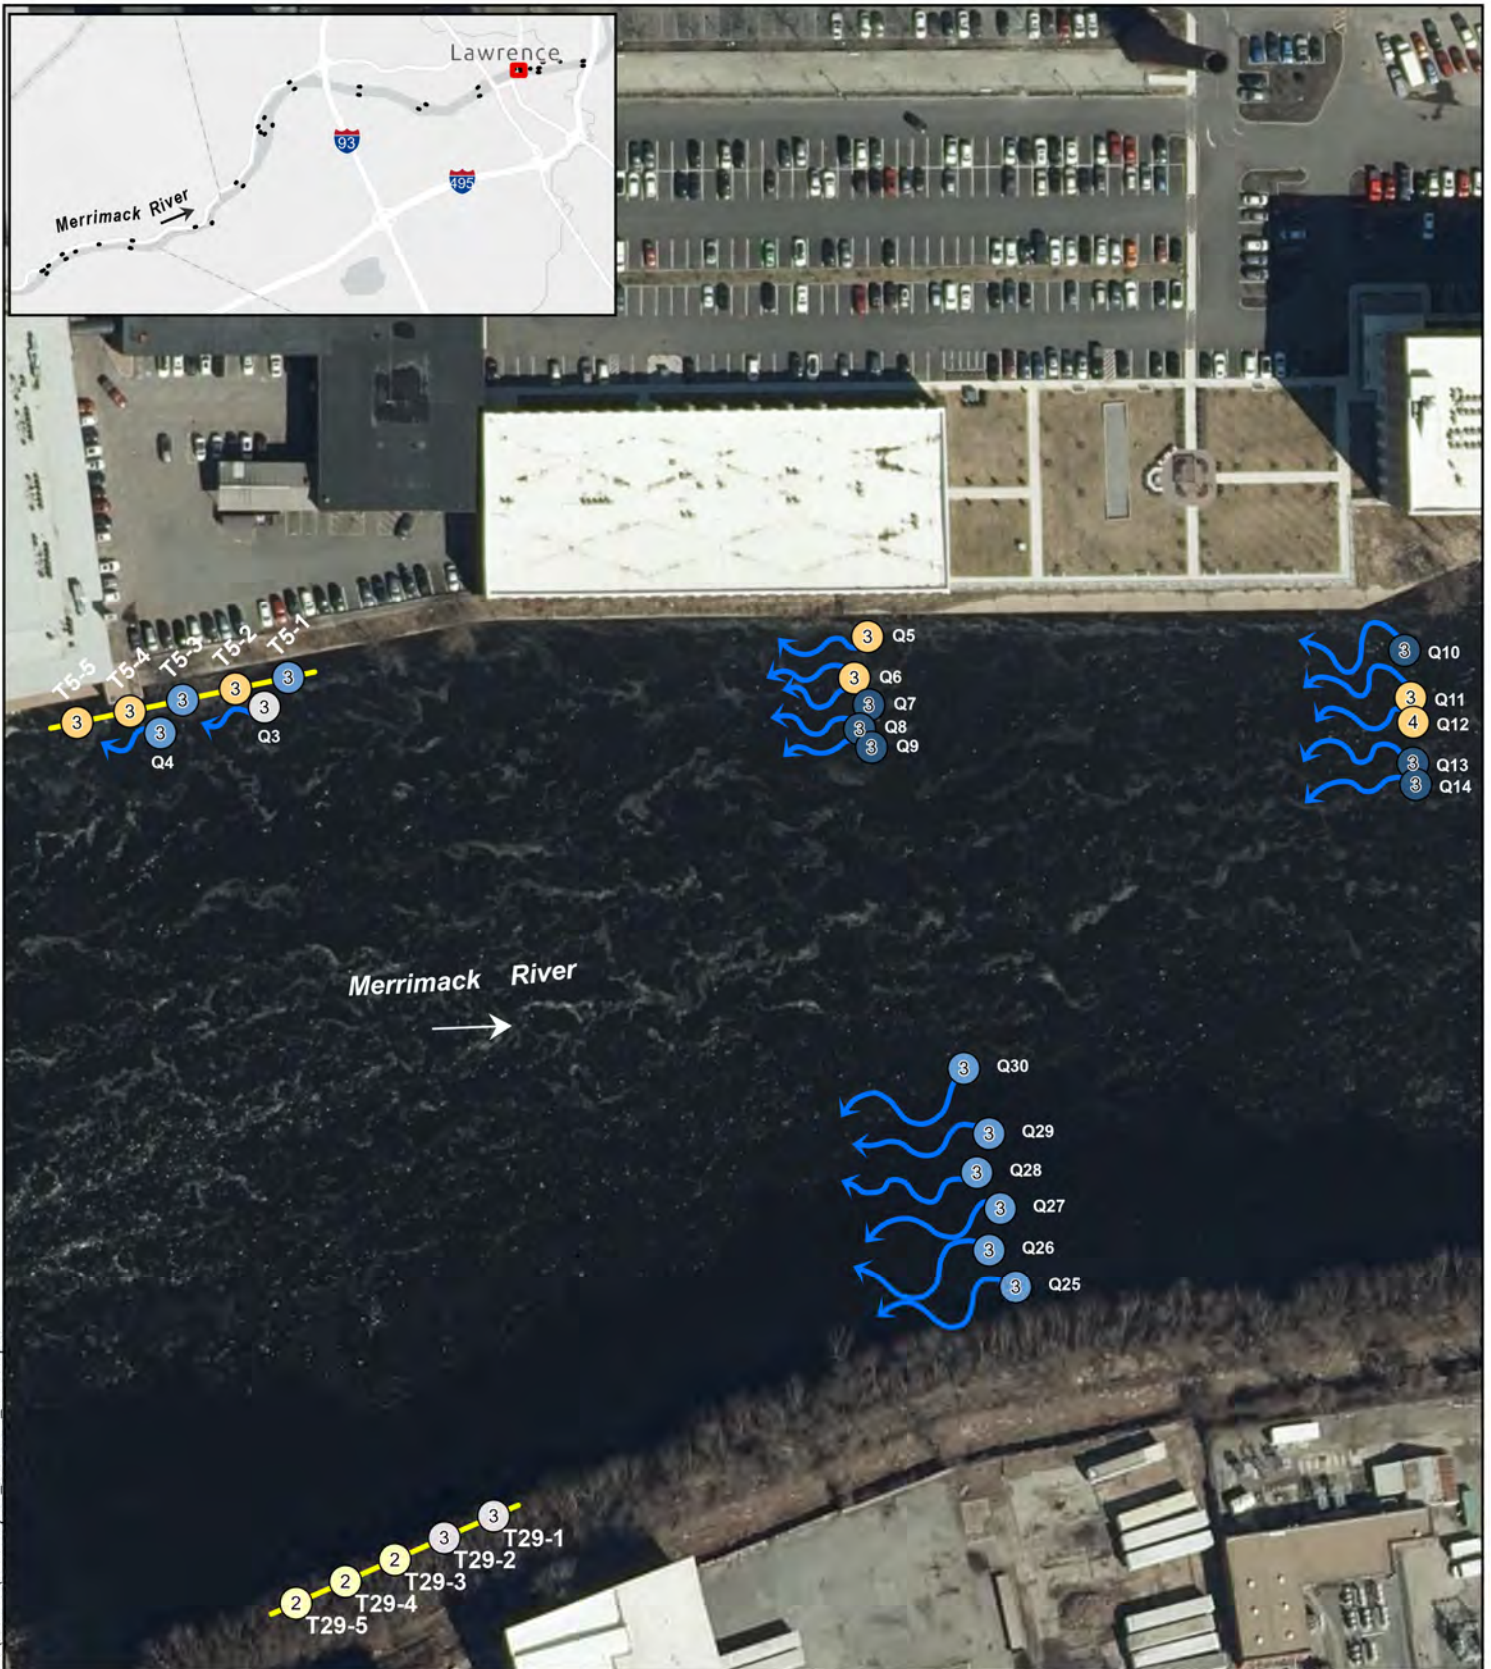
Appendix A - Figure 3
T5, T29, Q3 - Q14 and Q25 - Q30
Live Unionids and Species Distribution

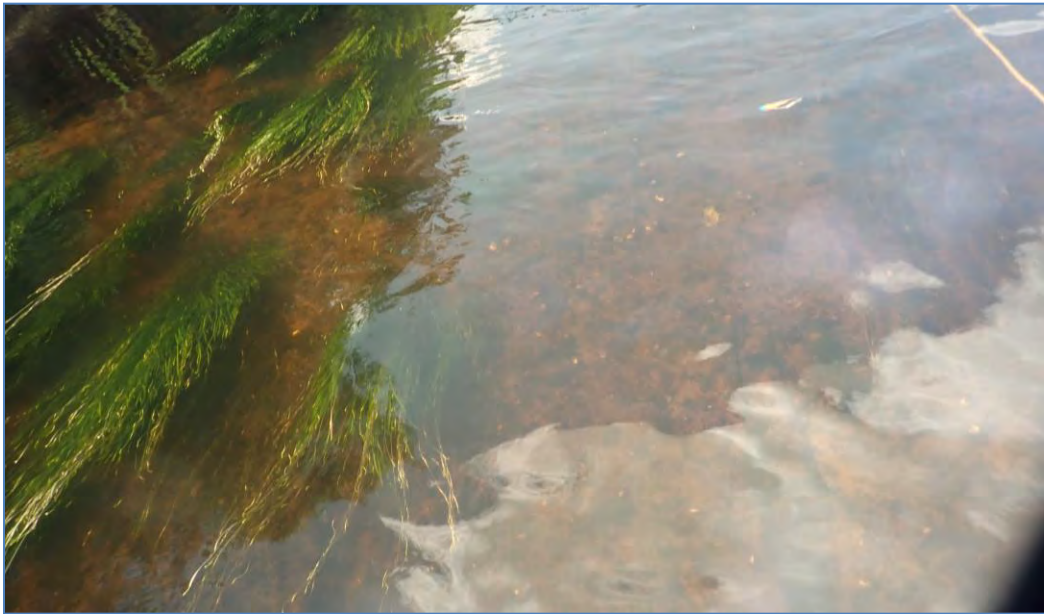
Photo # 5 Date: 22 August 2024

Representative image of substrate and submerged aquatic vegetation densities downstream of the Essex Dam.

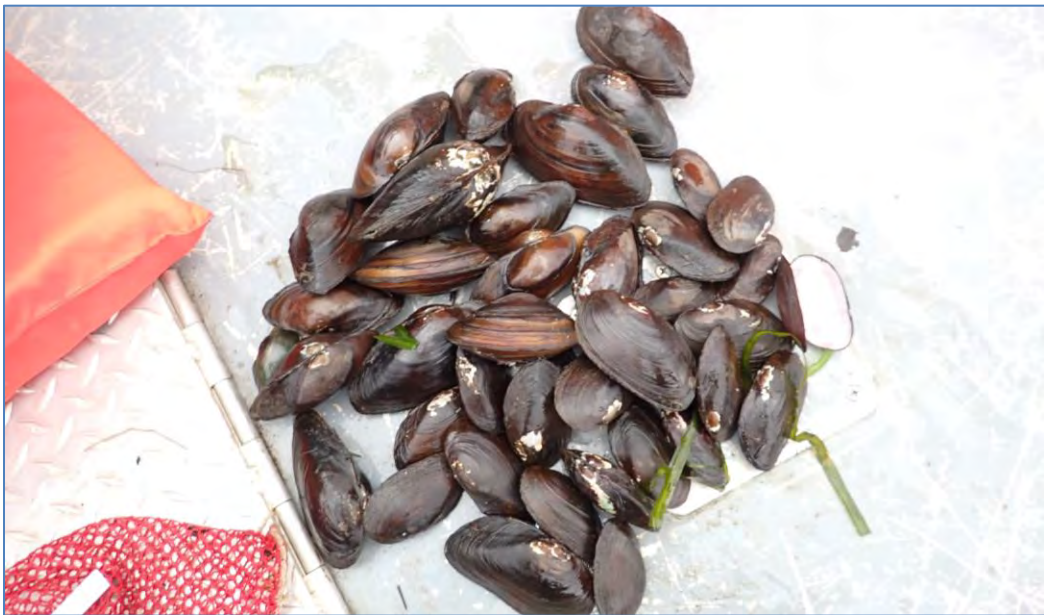
Photo # 42 Date: 18 August 2024

Representative image of a mixed catch in the lower impoundment upstream of Essex Dam.
