Condition Assessment of Historic Properties and Associated Canal System

Lawrence Hydroelectric Project (FERC
No. 2800)

May 6, 2025

Essex Company, LLC
Manchester, New Hampshire

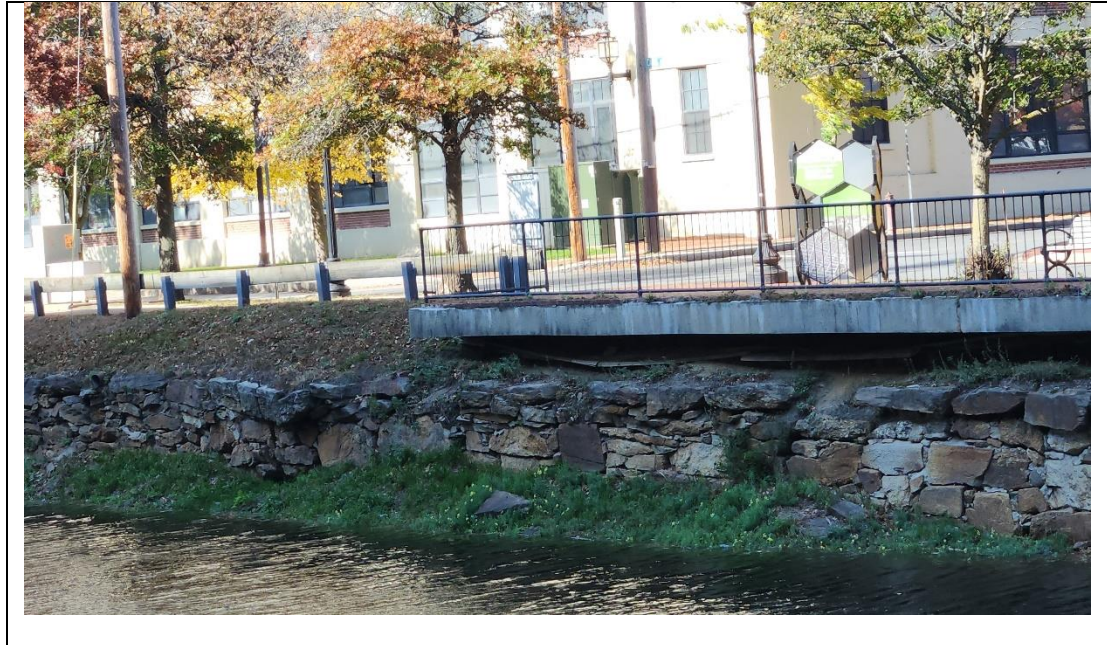
Wall Section	Station	Risk Level
NN23	31+35 to 33+00	1
Observations		
<p>This wall section is comprised of dry-laid stone. There are some minor areas with mortared joints, but this is limited to certain joints or locations rather than major portions of the wall section. The top of the wall section is covered by a large, concrete public observation deck with benches and a brick face. The crest and stones near the top of the wall appear to be leaning heavily into the canal, most likely caused by significant erosion of soils behind the canal wall and under the observation deck. It is noted there is no grass cover or material cover to prevent erosion under the observation deck. Additionally, this wall section is noted to have large areas of missing stones in various locations, including the crest.</p>		
Recommendations		
<p>The wall should be rebuilt with the same or similar materials and joints should be mortared to prevent erosion of soils from under the overhang. Essex is working with the Massachusetts Department of Conservation and Recreation and Lawrence Redevelopment Authority to coordinate repairs in 2026, which will require removal of the observation deck.</p>

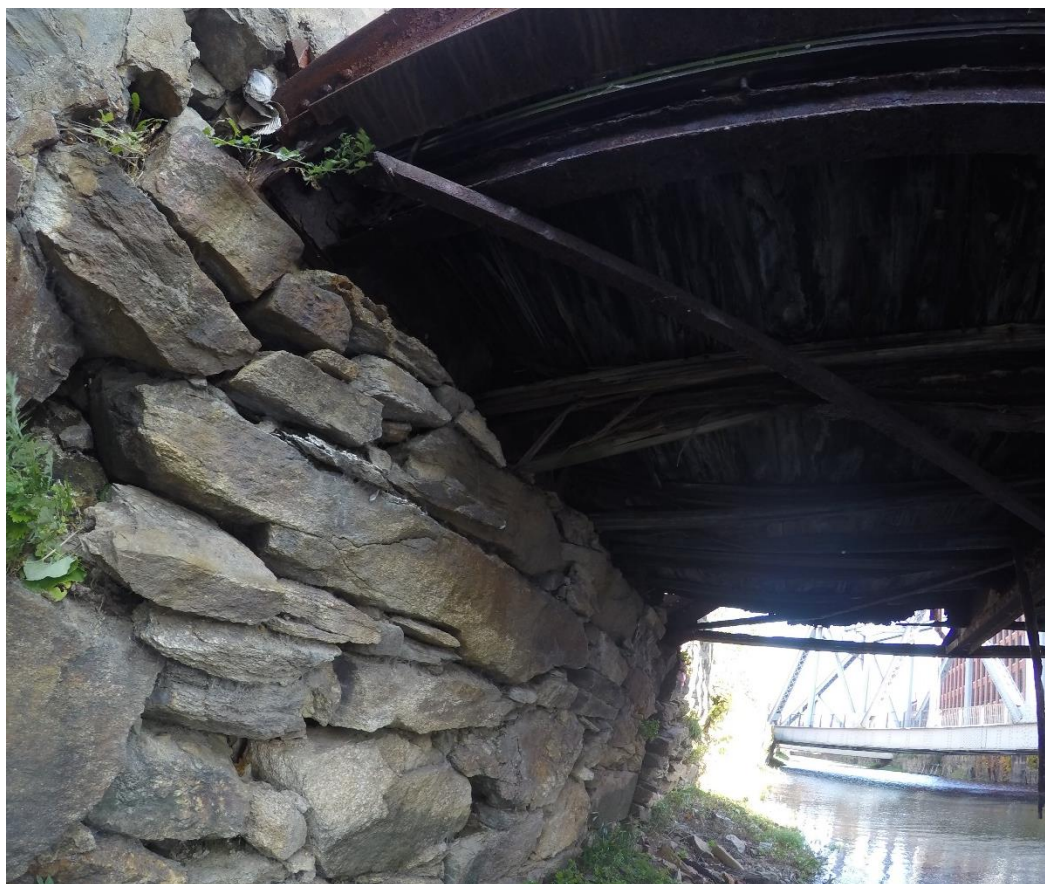
Wall Section	Station	Risk Level
NN27	40+50 to 40+90	2
Observations		
This wall section is comprised of dry-laid stone. However, the wall section is positioned under the old Pemberton Mill Bridge, which is blocked from usage by concrete jersey barriers. The stones of the wall section do not appear stable or properly plumb. The stones appear to be shifting and do not have a flush face. Unlike many of the bridges on the Lawrence canal system, there does not appear to be a solid brick, concrete, or mortared-stone abutment for the bridge to rest on, instead resting directly on the dry-laid stone.		
Recommendations		
The wall section below the bridge should be rebuilt in-kind with similar stone. The stones should provide a flush, uniform face on the canal side and joints should be mortared to add stability and prevent erosion/seepage from the abutment.

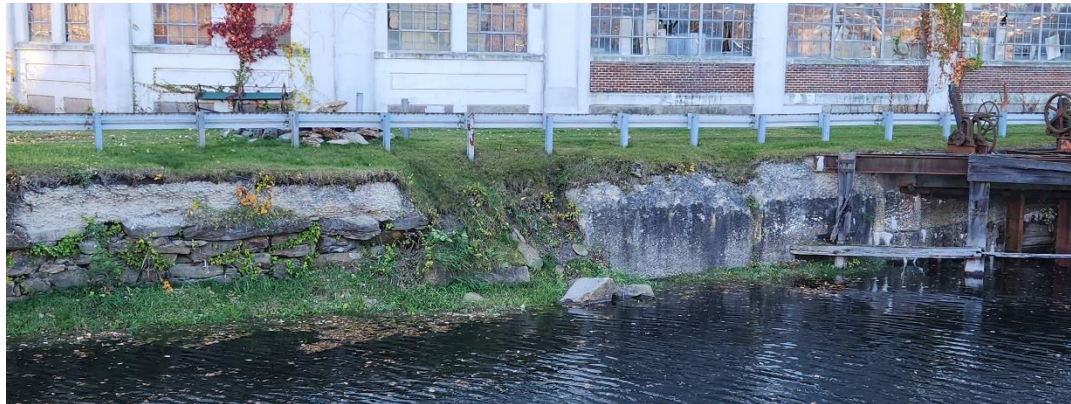
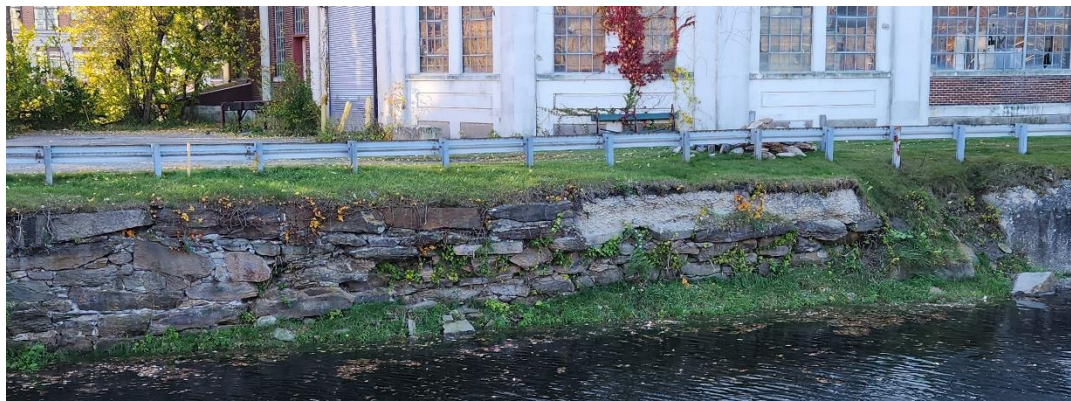
Wall Section	Station	Risk Level
NS23	38+95 to 39+35	1
Observations		
This wall section is comprised of dry-laid stone. The wall crest for a portion of the section has toppled over, and the remaining top stones are significantly leaning into the canal. Additionally, a portion of the wall about 5 feet in length has failed.		
Recommendations		
This wall section should be rebuilt in kind using similar stones. Joints should be mortared.

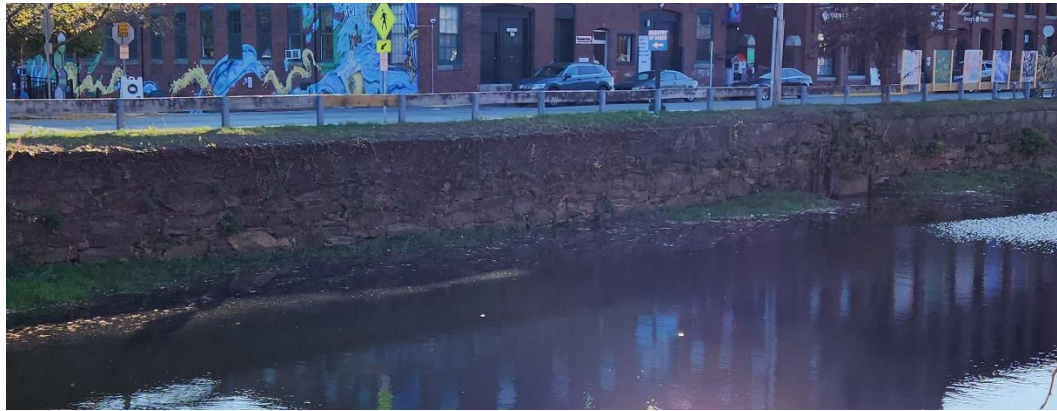
Wall Section	Station	Risk Level
NS30	49+35 to 51+40	2
Observations		
This wall section is comprised of dry-laid stone. The wall section has several large voids and dislodged stones. The wall section appears to be leaning into the canal, as evidenced by the heavy erosion of soil and sod on top of the wall crest. A portion of the wall includes concrete. This abandoned concrete has significant undermining.		
Recommendations		
The wall section should be rebuilt in kind using similar stones. Joints should be mortared.

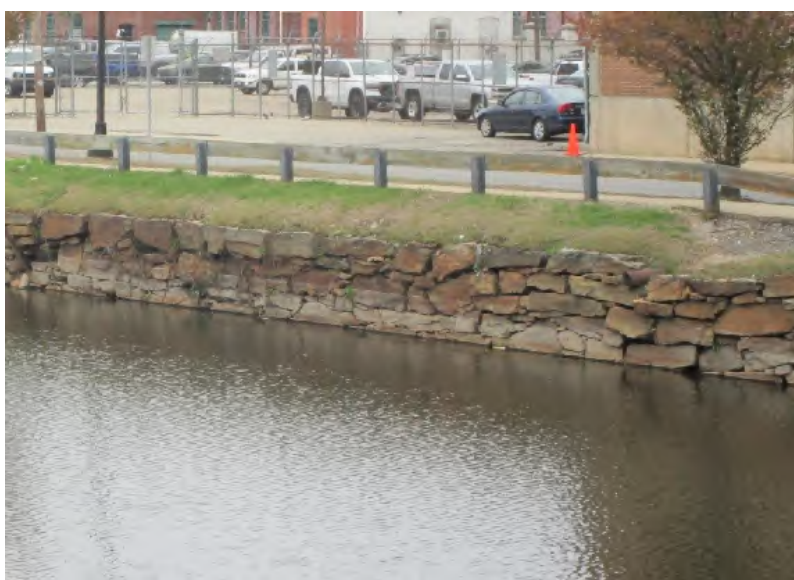
Observations: VG; top of wall uneven, potential differential settlement; appears unstable; out of plumb/top leaning significantly into canal; bowing; bulging; irregular and variable face; large open joints and voids; missing stones; dislodged stones; overburden pushing top stones towards canal. See photos below.

Recommendations: Rebuild this wall section with stone construction to match existing.

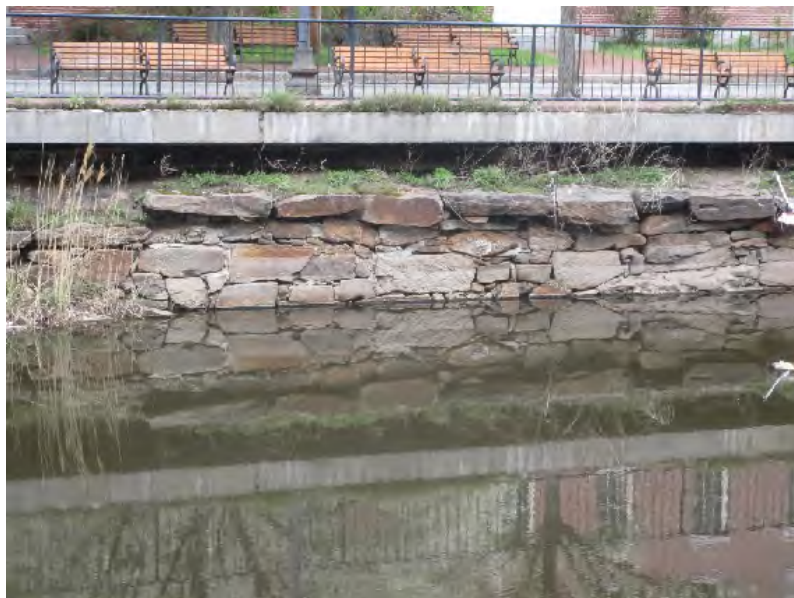
Observations: VG; out-of-plumb leaning/bowing significantly into canal; unstable; many top stones pushing into canal; major open voids; large concrete public observation deck above wall with benches. See photos below.

Recommendations: Rebuild this wall section with stone construction to match existing (top portion is in the worst condition)

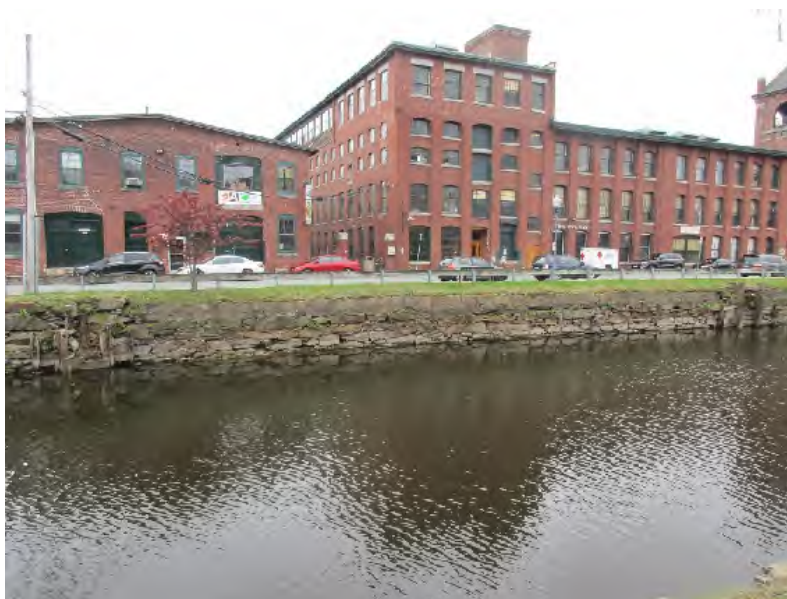
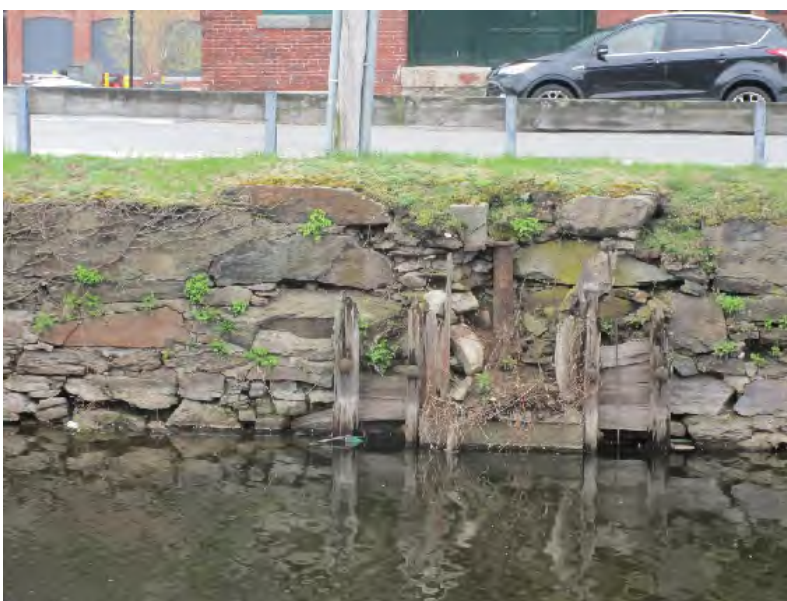
Observations: DLSW combined with rotten wood framework; abandoned utility structure; heavy VG; appears unstable; partial collapse for top portion; major open joints and voids; missing stones; erosion. See photos below.

Recommendations: Demo wooden utility structure and rebuild this wall section with stone construction to match existing.

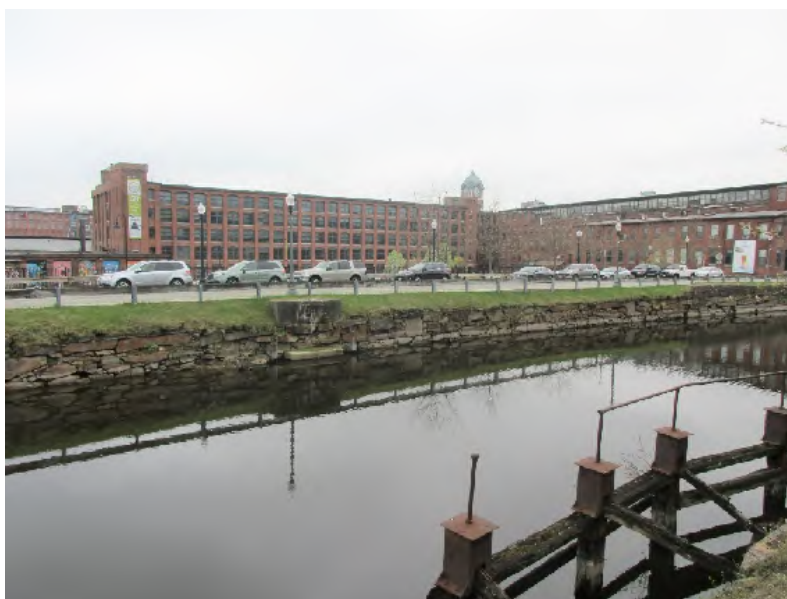
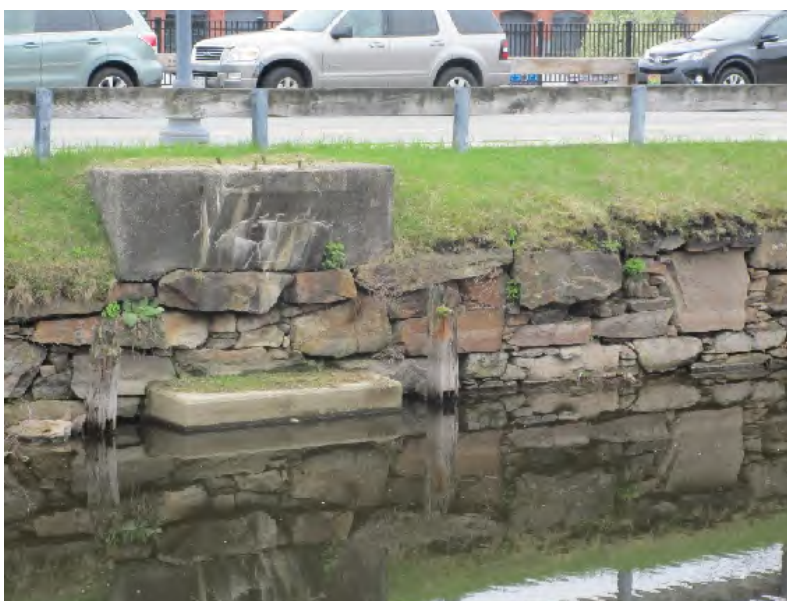
Wall Section: Item #S45; Station 44 + 50 to 45 + 90; Risk Level 2

Observations: VG; out-of-plume and leaning into canal; appears unstable; major open joints and gaps; dislodged stones; abandoned concrete post foundation atop unstable DLSW stones; erosion along top supporting sidewalk and street. See photos below.

Recommendations: Demo concrete post-foundation structure and rebuild this wall section with stone construction to match existing.
